Accident- Tank Farm explosion and fire in Deer Park, Texas

15 PDH

**Professional Development Hours (PDH) or
Continuing Education Hours (CE)
Online PDH or CE course**

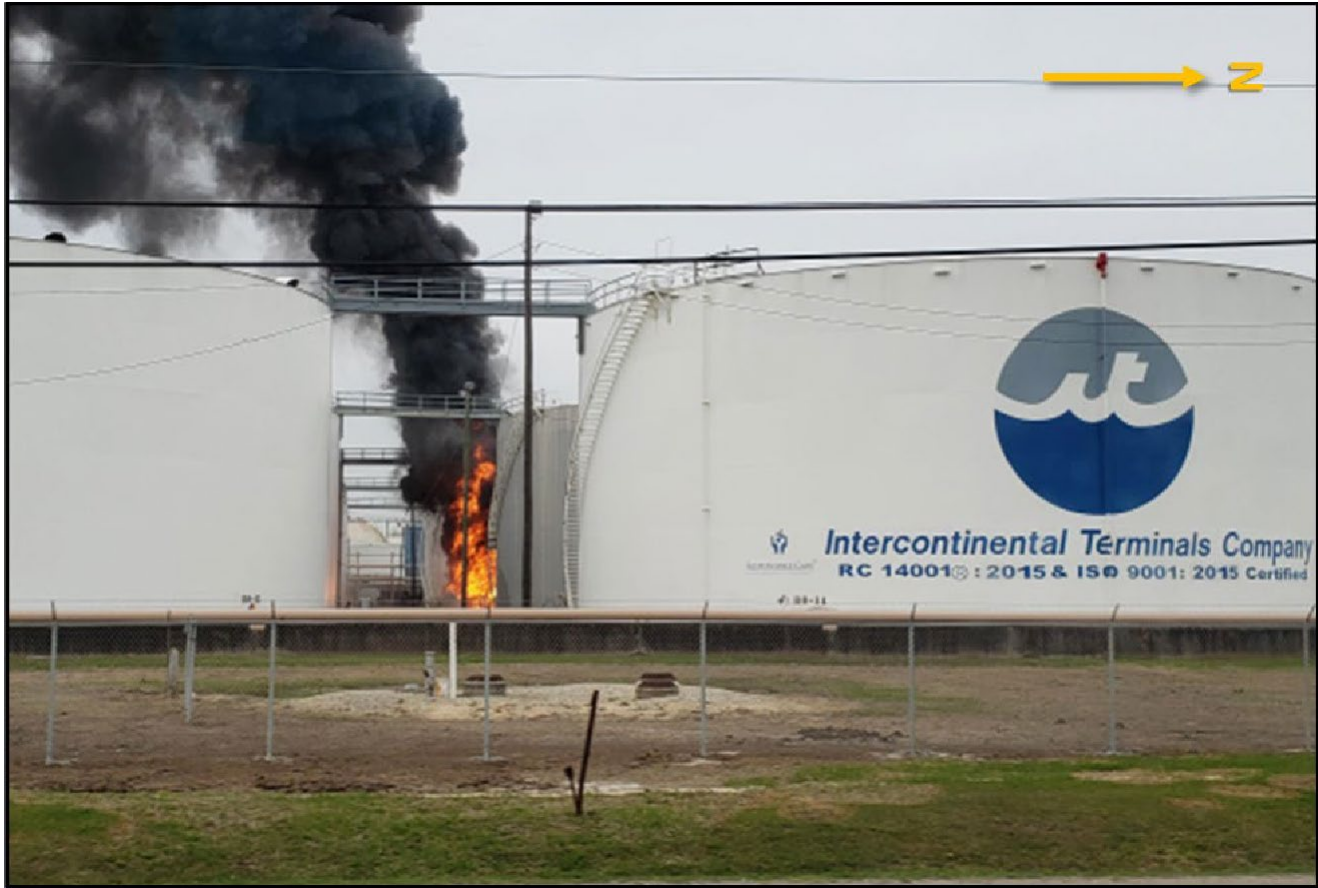
Figure 11. Initial ITC tank fire that ignited at Tank 80-8 on March 17, 2019. (Credit: HCFMO, annotations by CSB)

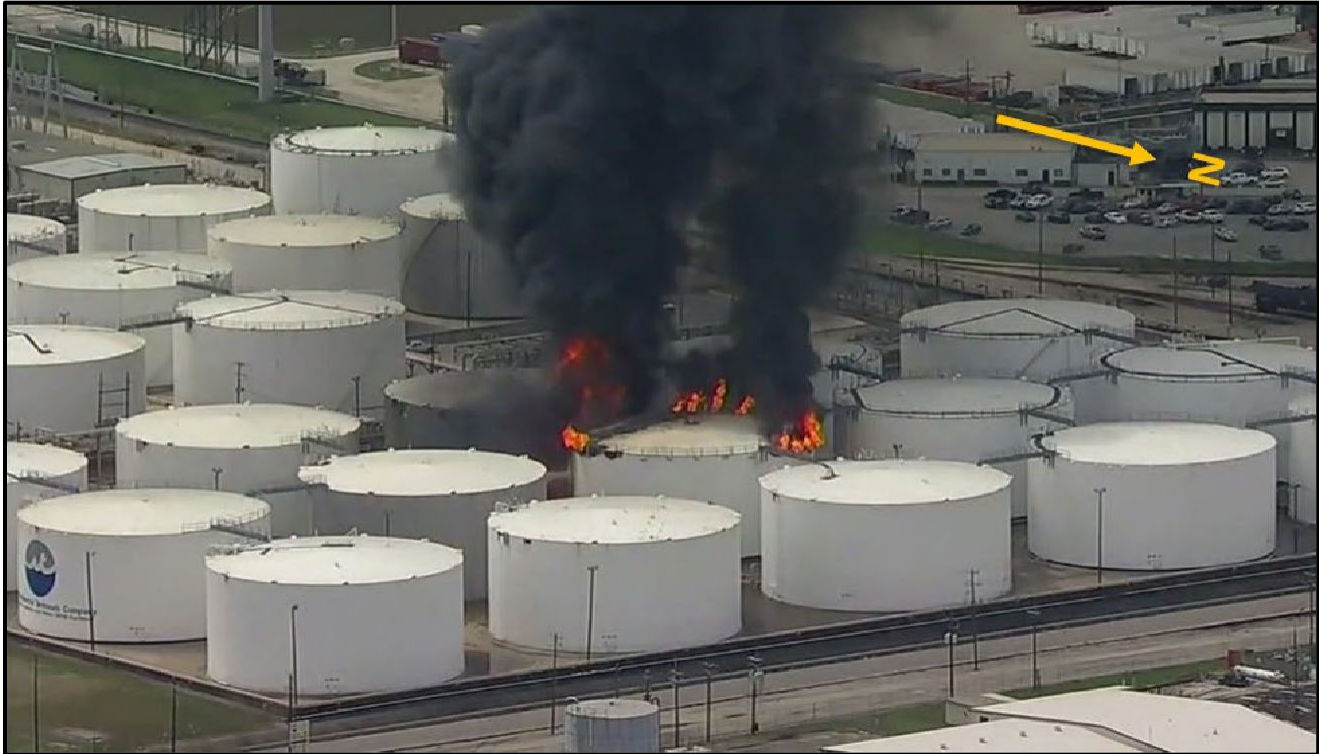
Given that Tank 80-8 was situated in the center of the First & Second 80's tank farm, the initial response efforts focused on using water to cool the tanks, control the fire, and prevent it from spreading. Since Tanks 80-9 and 80-12 were both empty, resources were not focused on cooling these tanks; however, a wind shift caused the fire to inundate the Second 80's tank farm manifold located in this area, which connected to process piping from other locations in the facility.^a As a result, the ERT positioned a portable fire monitor between Tanks 80-11 and 80-12 to assist with cooling efforts and prevent the combustible insulation surrounding Tank 80-11 from reigniting. At this time, fire was visible near the rim of Tank 80-8, with flames being expelled through the roof vents (**Figure 12**).

Figure 12. ITC fire involving Tank 80-8 on the morning of March 17, 2019. (Credit: ABC13 Houston, annotations by CSB)

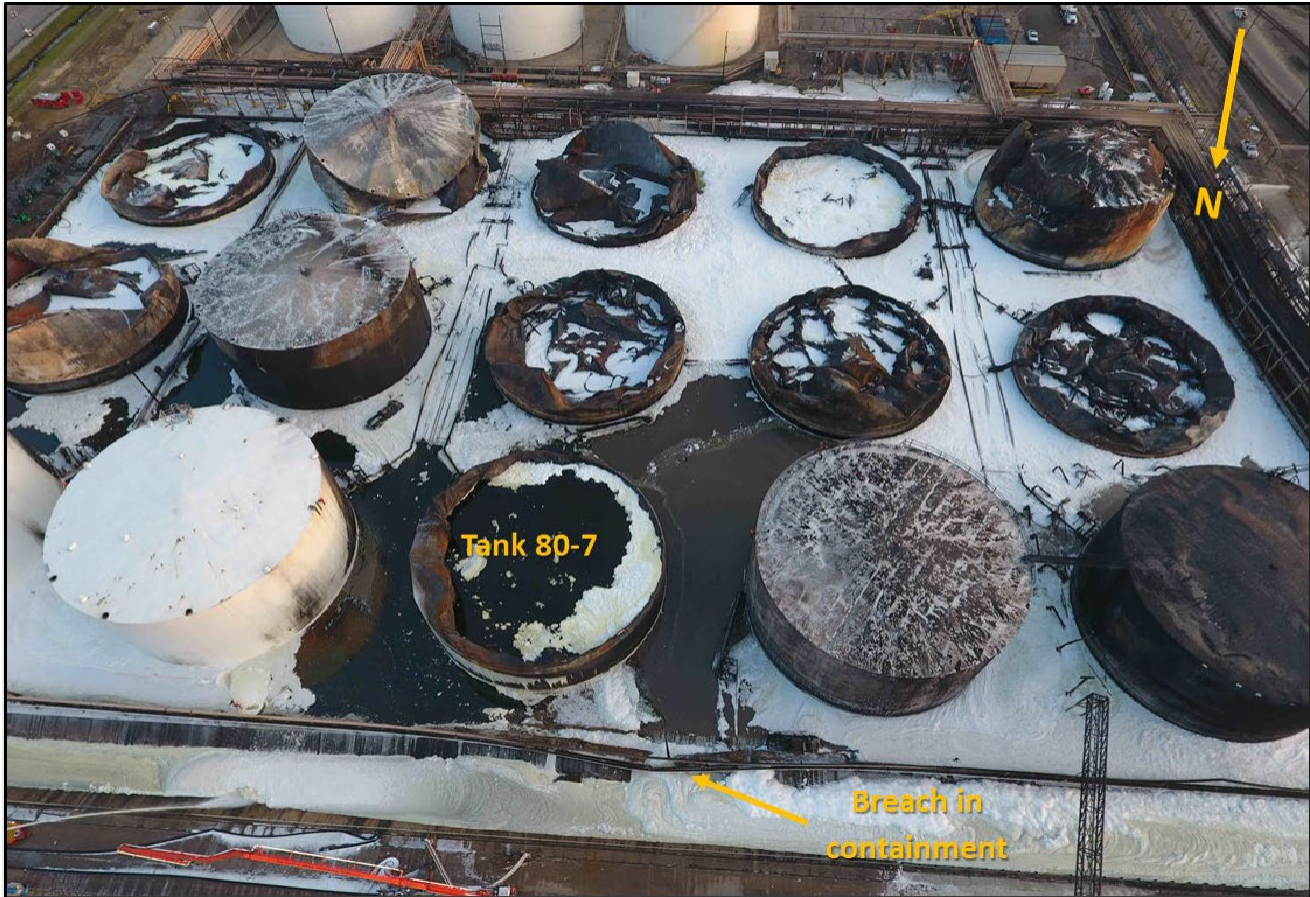
On Friday, March 22, 2019, at around 12:15 p.m., the secondary containment wall surrounding the First & Second 80’s tank farm partially collapsed near Tank 80-7. The containment wall displaced laterally due to excessive lateral soil and hydrostatic pressures.^b The containment wall failure allowed the mixture of released hydrocarbon products, firefighting foam, and contaminated water previously confined to the tank farm to exit the containment area and enter the ditch running adjacent to Tidal Road on the north side of the tank farm

Figure 16. Overhead view of the First & Second 80's tank farm containment wall failure that allowed materials to enter the surrounding waterways on Friday, March 22, 2019. (Credit: ITC, annotations by CSB)

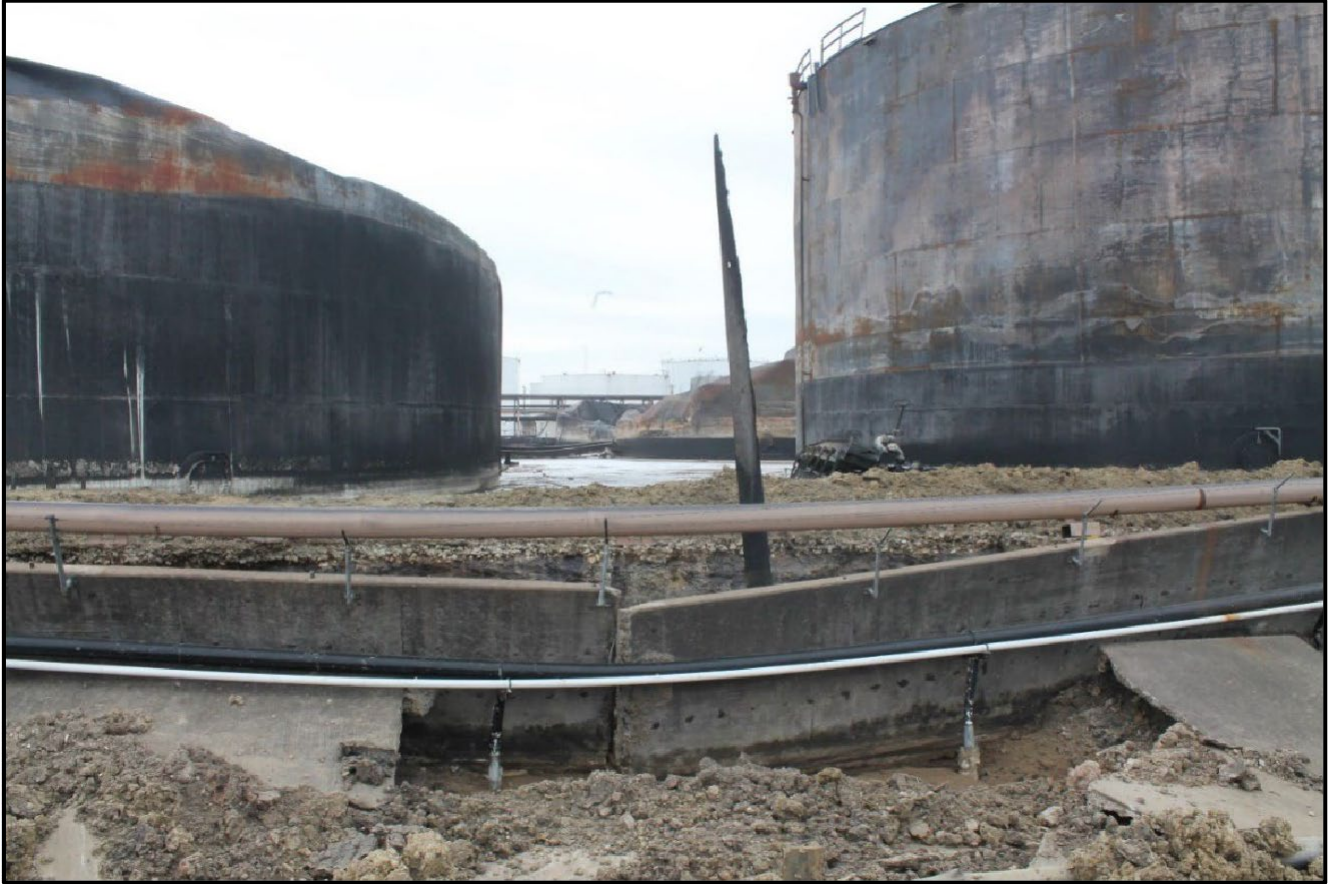
(Figure 16). The release also resulted in the potential for elevated levels of volatile organic compounds (VOCs)^a in the immediate industrial area. As a result, ITC notified its industrial neighbors and local state parks of the potential exposure and recommended that they shelter in place. The breach in the containment wall measured roughly 10 feet in width (Figure 17).

Figure 17. Close-up view of the First & Second 80's tank farm containment wall breach that occurred on Friday, March 22, 2019. (Credit: HCFMO).

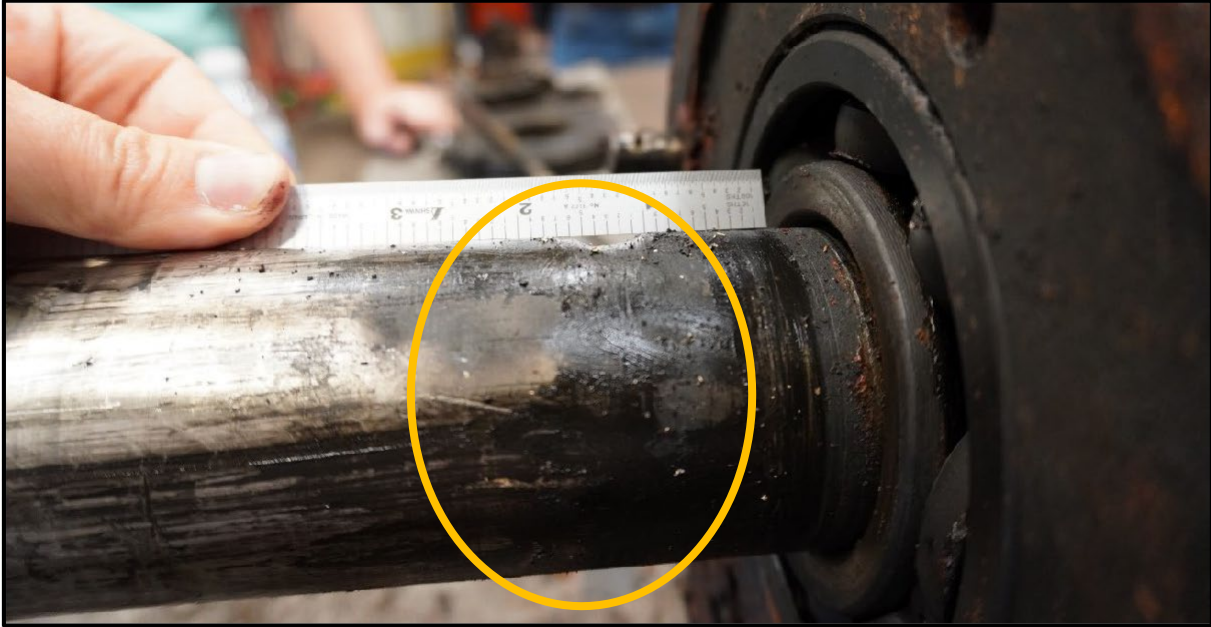
Following the incident, the Tank 80-8 circulation pump skid was transported to a third-party facility for inspection and teardown (**Figure 22**). The pump was fully disassembled to allow for visual examination of its individual components and documentation of their condition. Severe degradation and wear damage were observed on the pump shaft, seal, and outboard bearing. Substantial abrasive wear was visible on the pump shaft adjacent to the seal on the inboard side of the bearing housing (**Figure 23**). Extensive contact wear was also visible on the seal gland (**Figure 24**).

Figure 23. The severe abrasive wear damage observed on the Tank 80-8 pump shaft adjacent to inboard side of bearing housing, on August 30, 2019. (Credit: CSB)

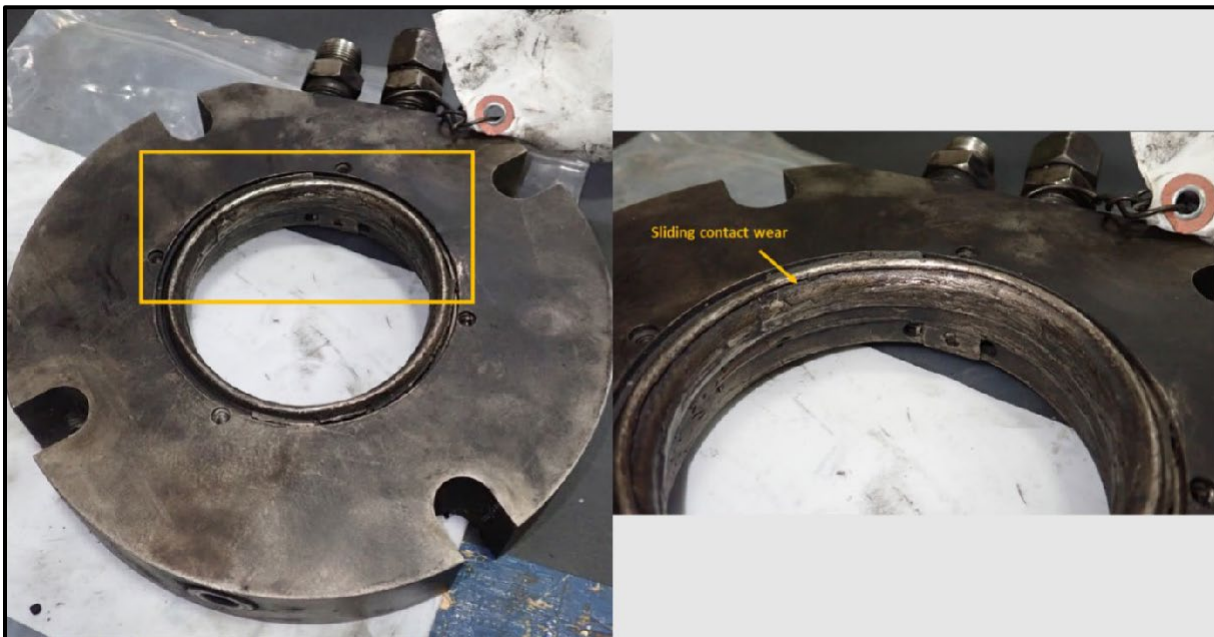
Figure 24. Smear metal on inside surface of seal gland that indicates sliding contact with the pump shaft. (Credit: Stress Engineering)

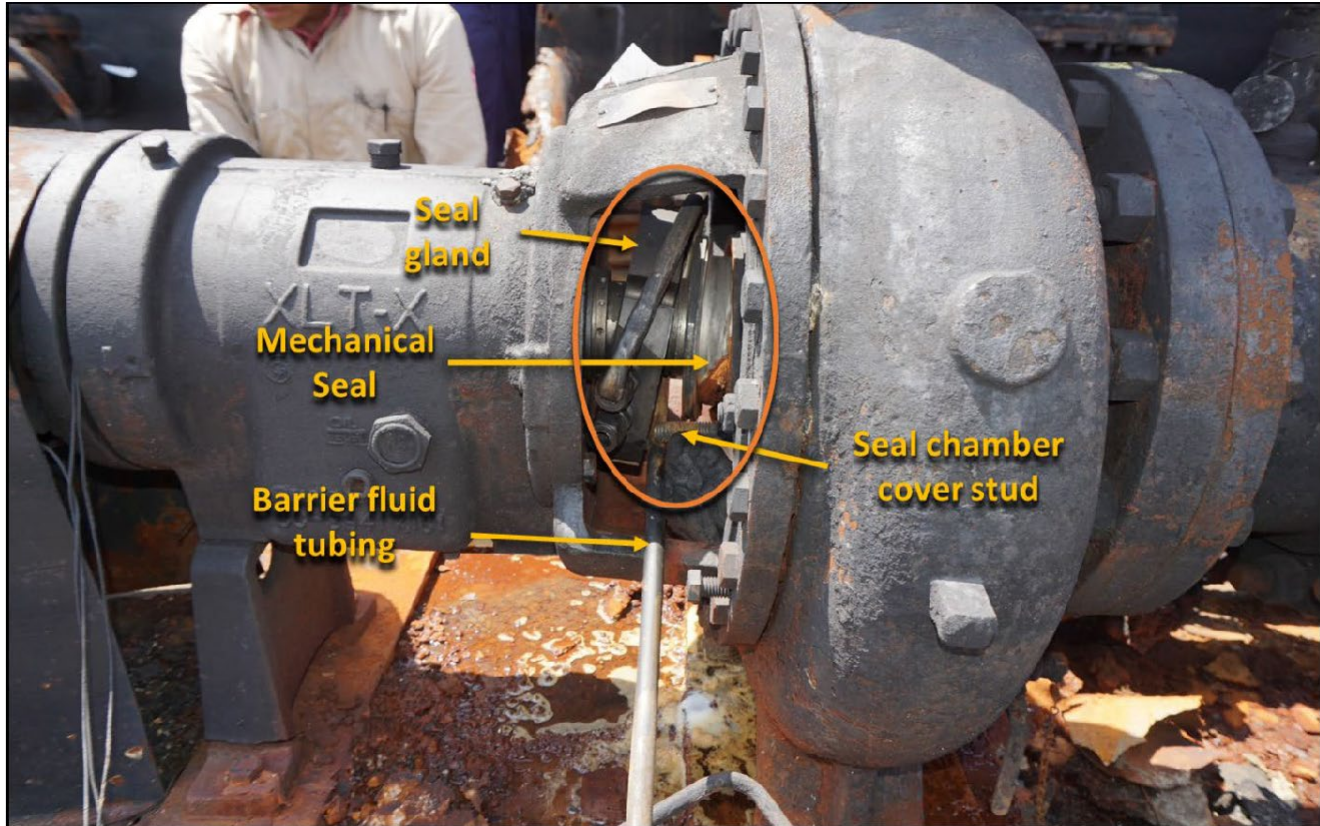
The CSB determined that the cause of the incident was the release of flammable butane-enriched naphtha vapor from the failed Tank 80-8 circulation pump, which accumulated in the area and ignited, resulting in a fire. Contributing to the severity of the incident were the absence of a flammable gas detection system to alert the operators to the flammable mixture before it ignited approximately 30 minutes after the release began, and the absence of remotely operated emergency isolation valves (ROEIVs) to safely secure the flammable liquids in Tank 80-8 and the surrounding tanks in the First & Second 80's tank farm.

Figure 26. Tank 80-8 circulation pump. This photo shows the point of separation observed between the mechanical seal gland and seal chamber cover where the butane-enriched naphtha product released. (Credit: CSB).

Develop and implement a condition monitoring program for all pumps in highly hazardous chemical service at the ITC Deer Park terminal. Ensure that condition monitoring equipment is programmed with control limits, including but not limited to vibration, consistent with ANSI/HI 9.6.9.-2018, that trigger alarms when control limits are exceeded, and that operating procedures and training reflect the appropriate actions to take when an alarm is triggered.

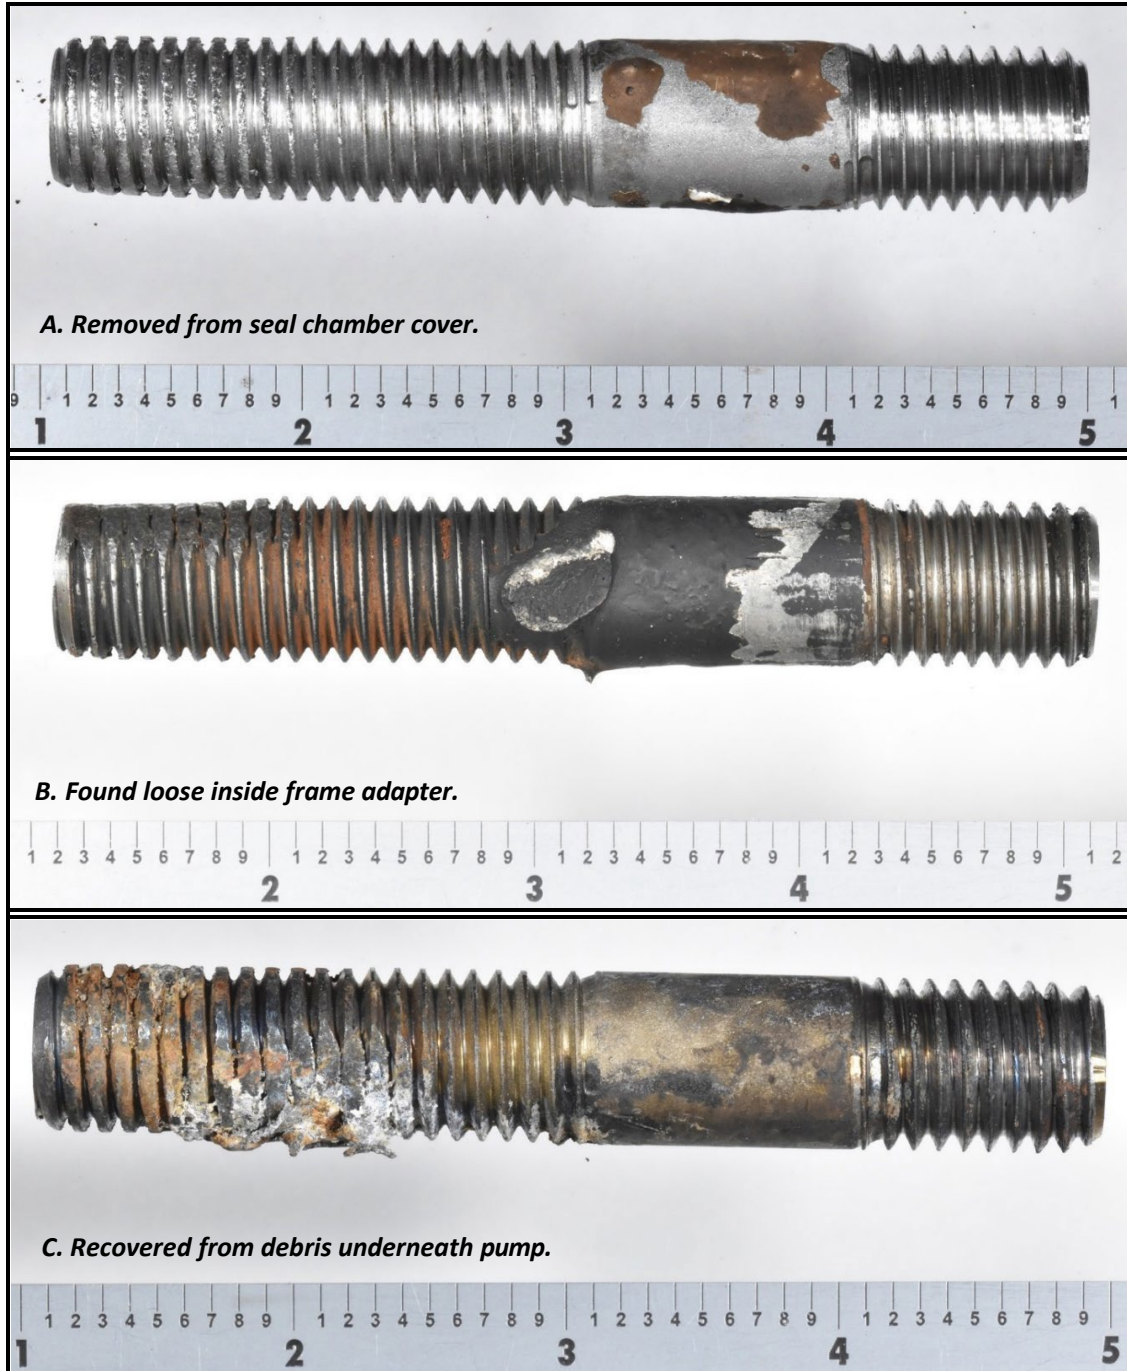
^a The internal threads of the blind holes in which the studs were located, as well as the threads on the studs where they engaged the blind holes, were in good condition.

Figure 27. Three seal chamber cover studs recovered from Tank 80-8 circulation pump, post-cleaning. The longer threaded ends passed through the slots in the seal gland, while the shorter threaded ends were engaged in the seal chamber cover. (Credit: Stress Engineering)

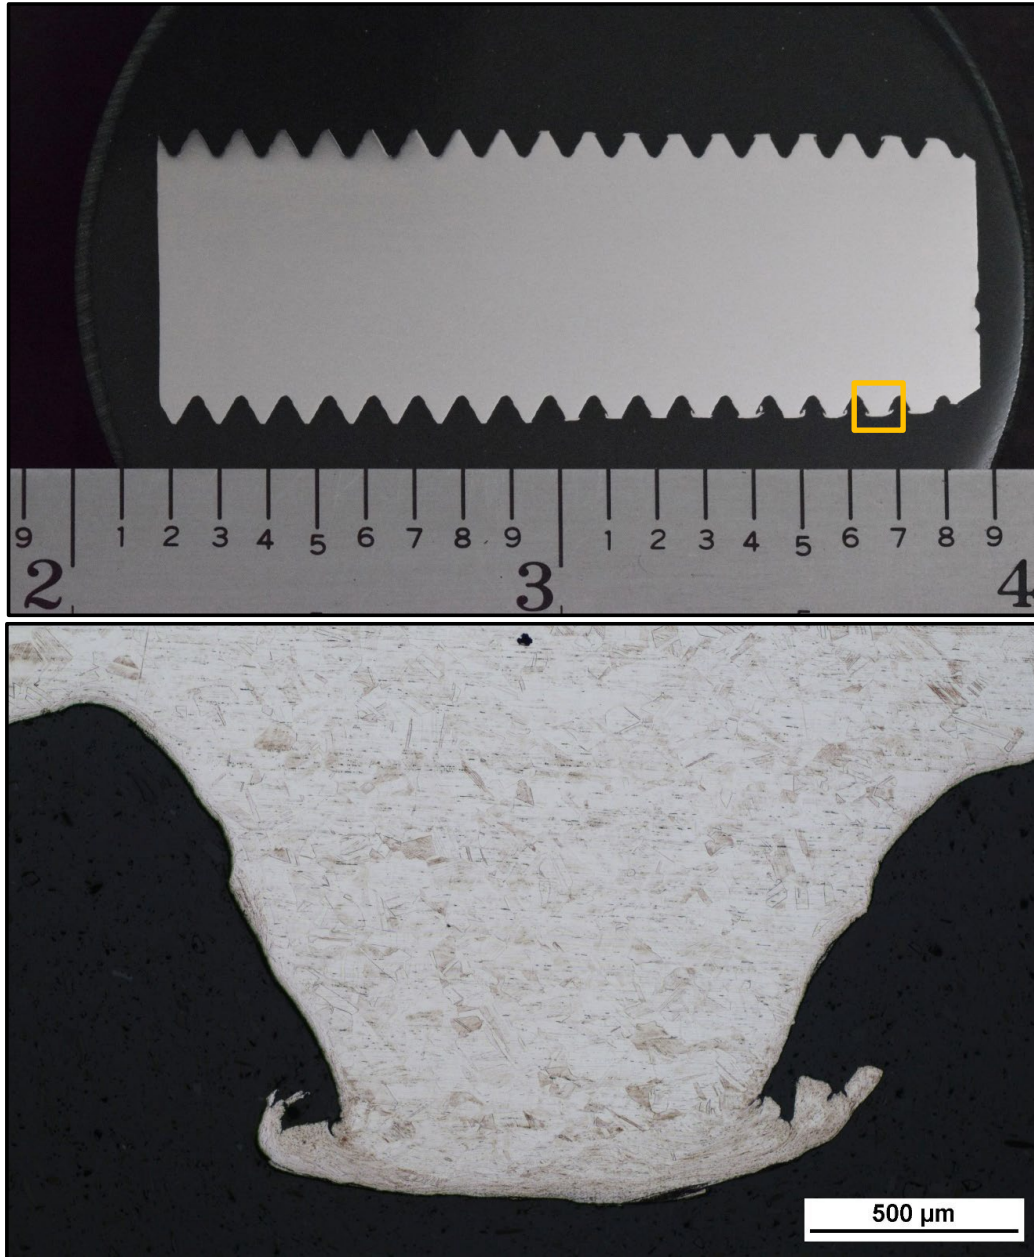
Figure 28. Section of threads from seal chamber stud that projected through slots in seal gland, where flattening of the thread crowns was observed (Credit: Stress Engineering)

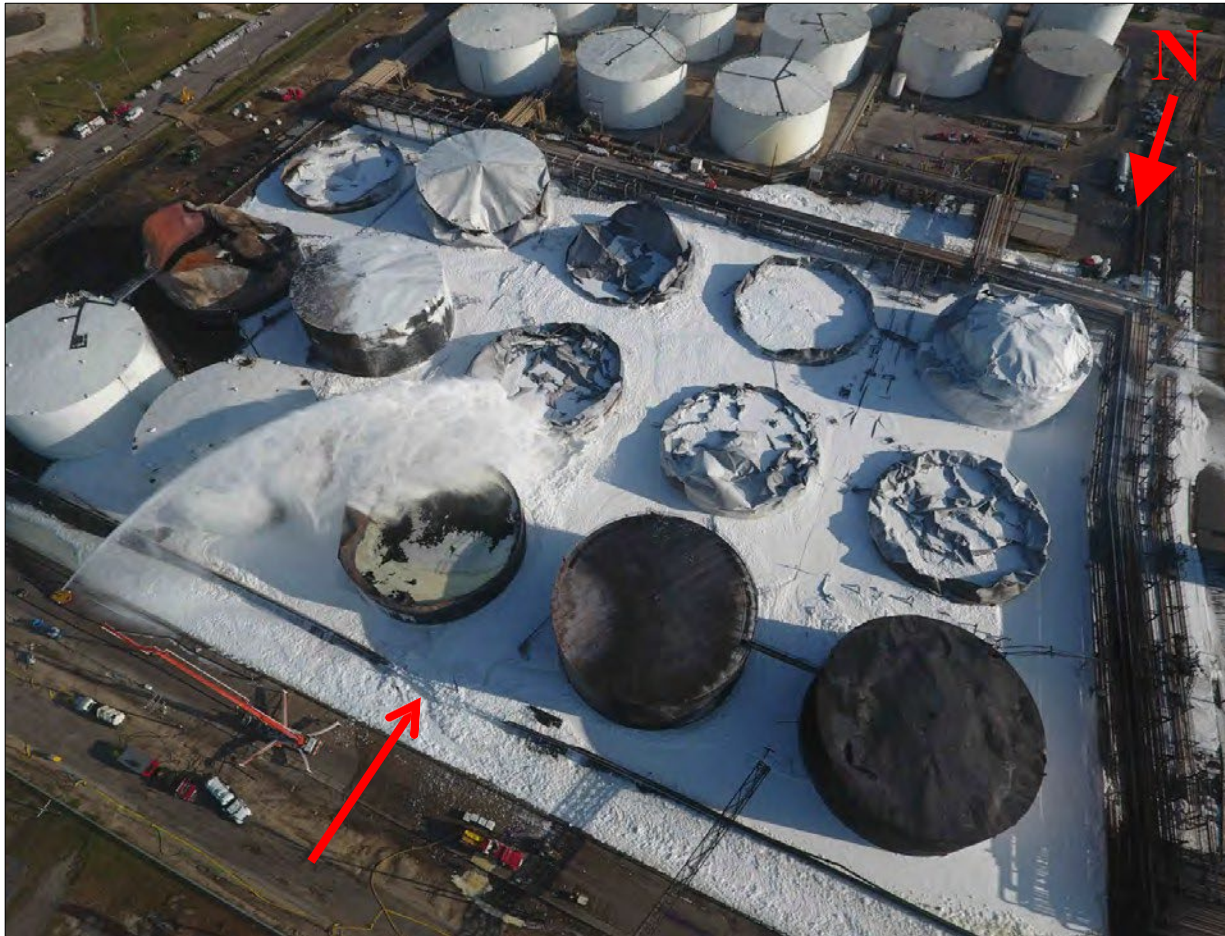
Photo 4: Containment wall failure (red arrow) during fire suppression efforts¹²

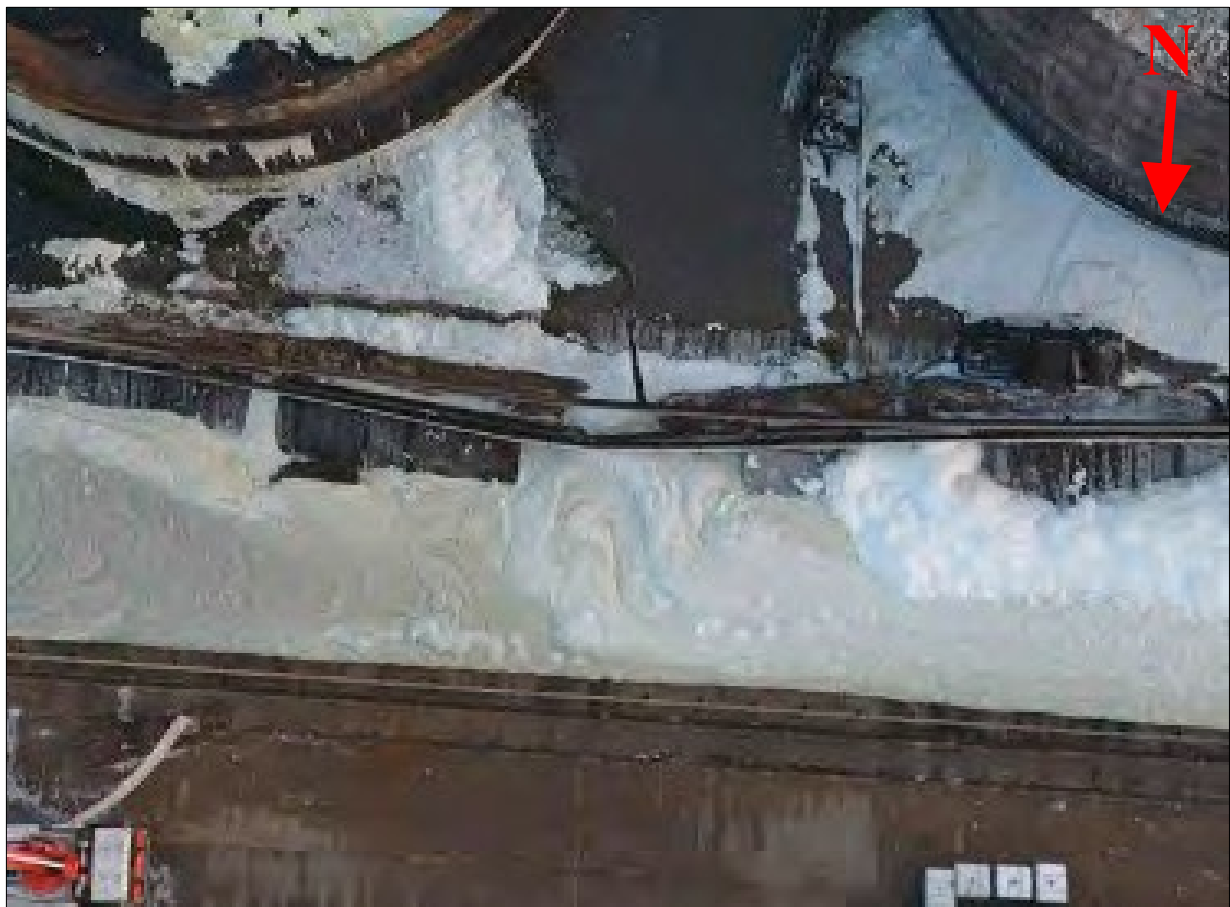
Photo 6: Closeup from aerial view of containment wall failure¹⁴

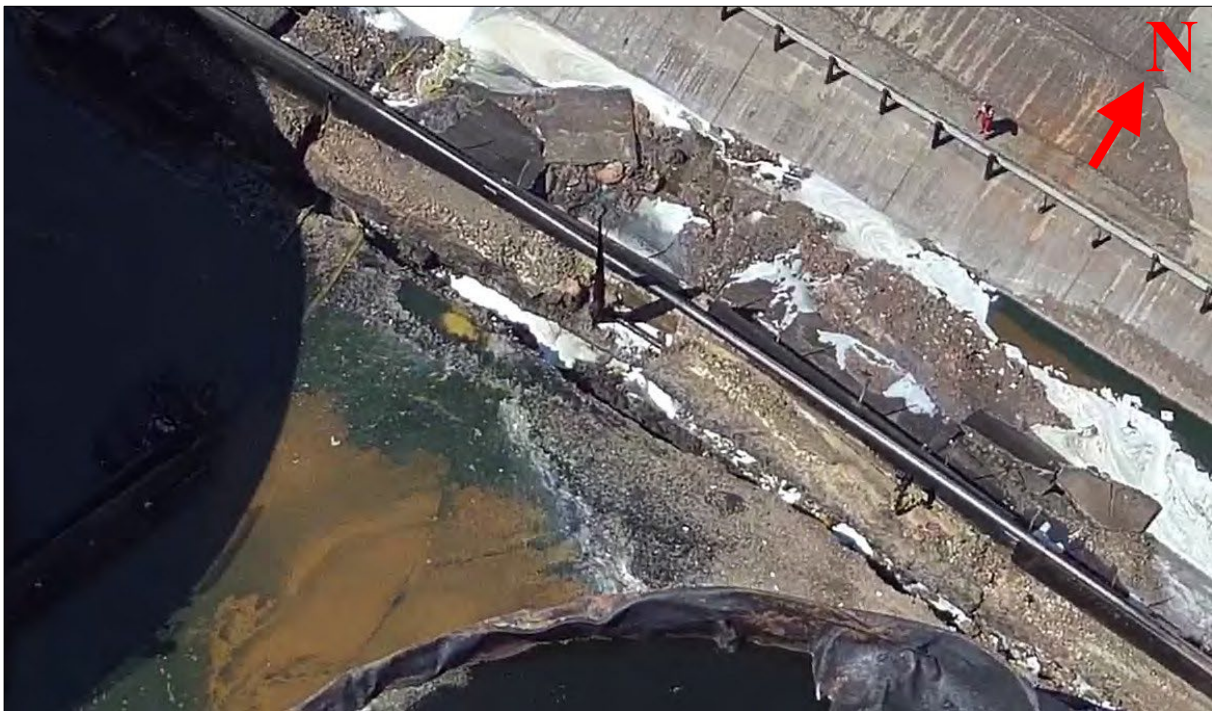
Photo 7: Aerial photo of containment wall failure after water flow stopped and before temporary dike wall was constructed¹⁵

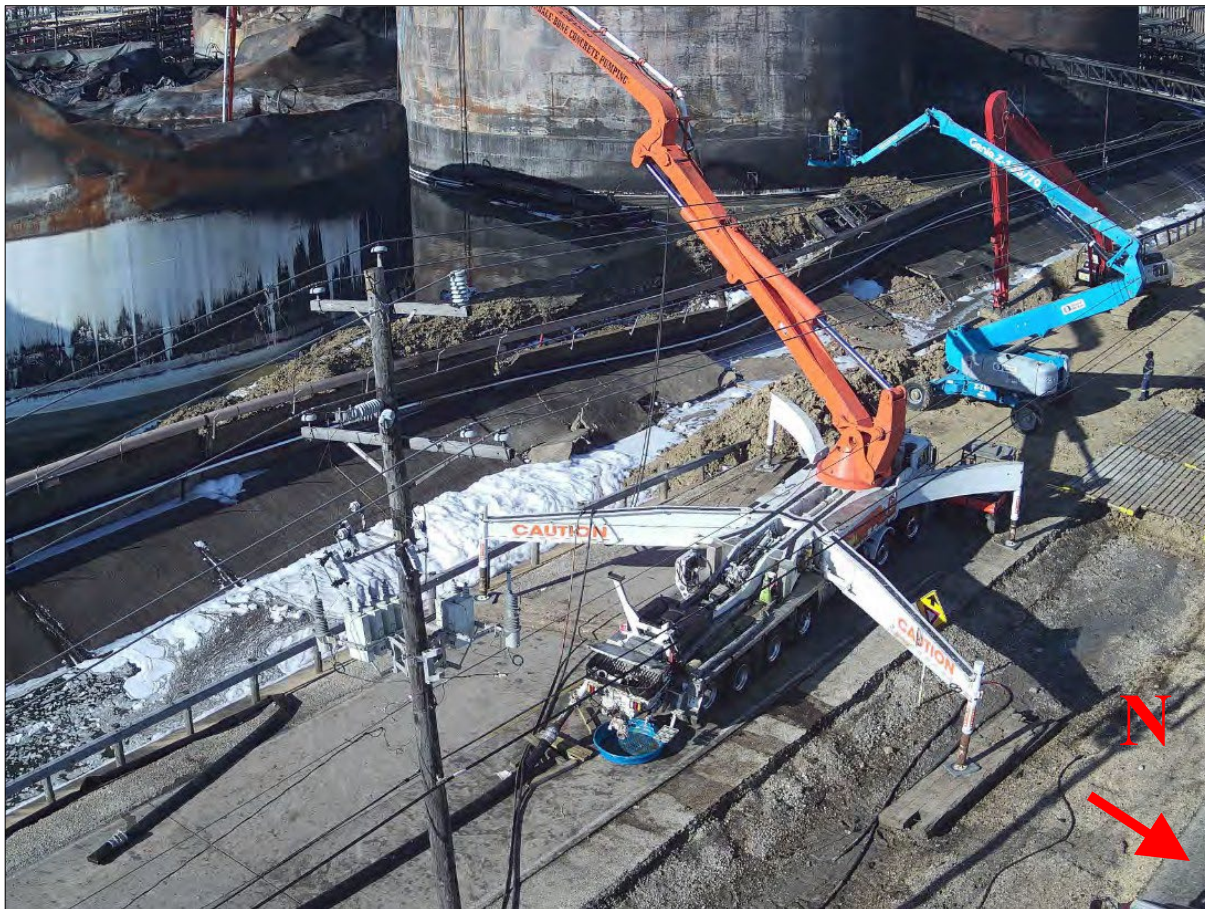
Photo 8: View of containment wall failure, after temporary dike wall was constructed¹⁶

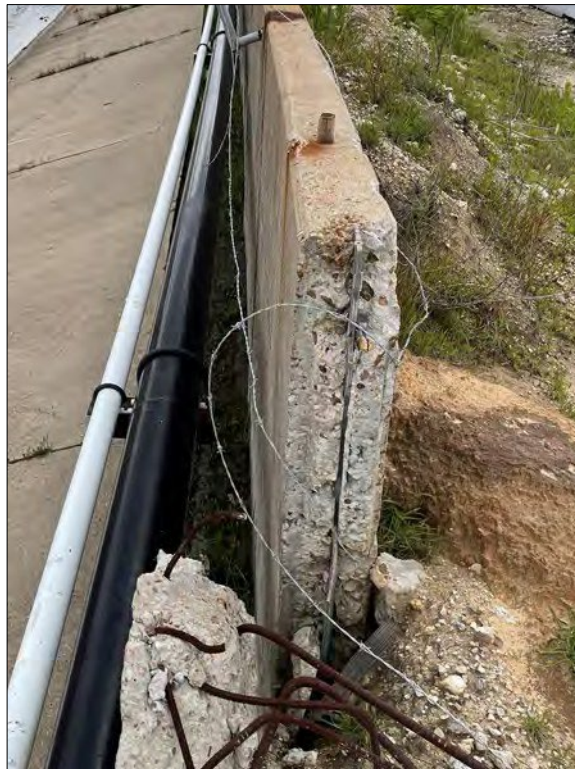
Photo 14: Torn waterstop and displaced wall. Upper section of wall that was displaced has been partially demolished during remediation efforts.

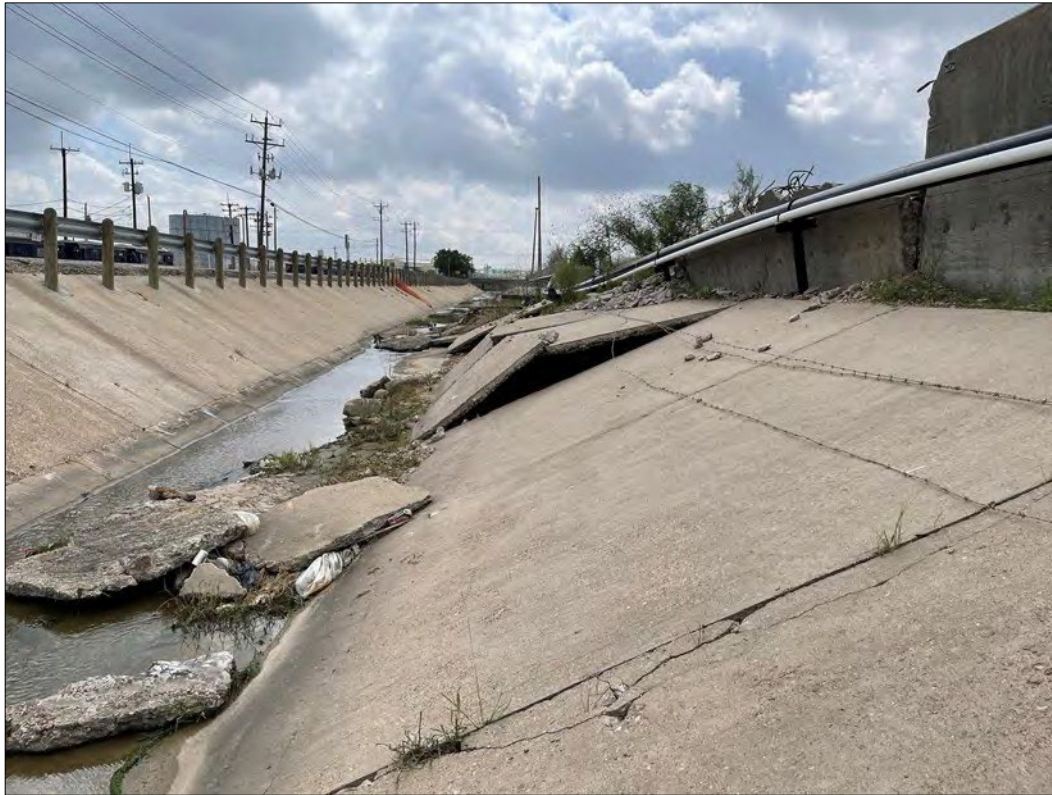
Photo 16: Damaged Section of Drainage Ditch, looking east

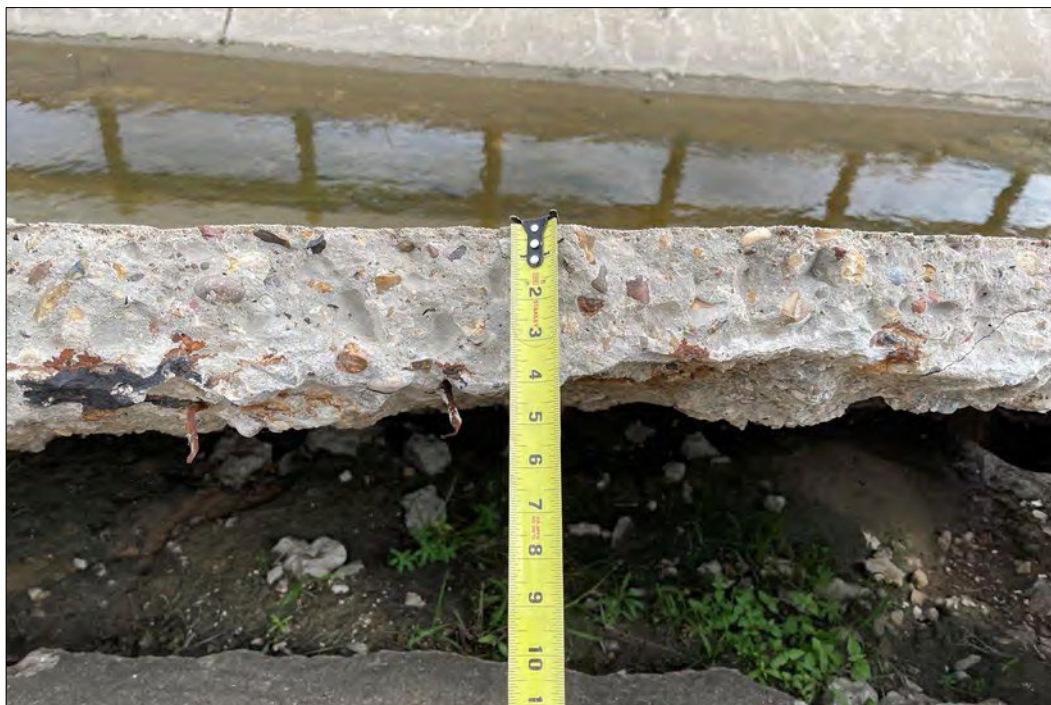
Photo 17: Displaced section of concrete slab that formed sloped sidewall of ditch
