Accident- Tank Farm explosion and fire in Deer Park, Texas

15 PDH

**Professional Development Hours (PDH) or
Continuing Education Hours (CE)
Online PDH or CE course**

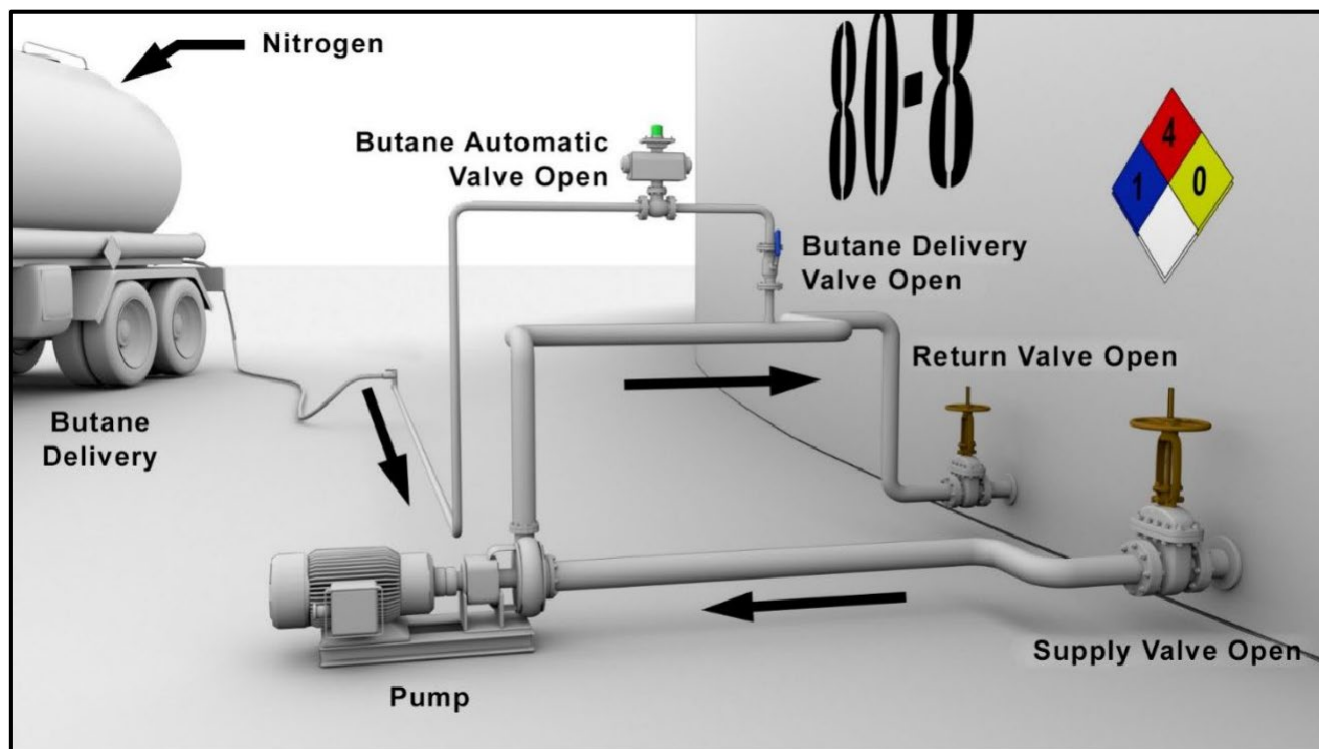
Figure 6. Simplified schematic showing ITC's butane injection system prior to 2016. The arrows in the figure show the butane flow direction and the naphtha product circulation path through the piping. Note: schematic not to scale. (Credit: CSB)

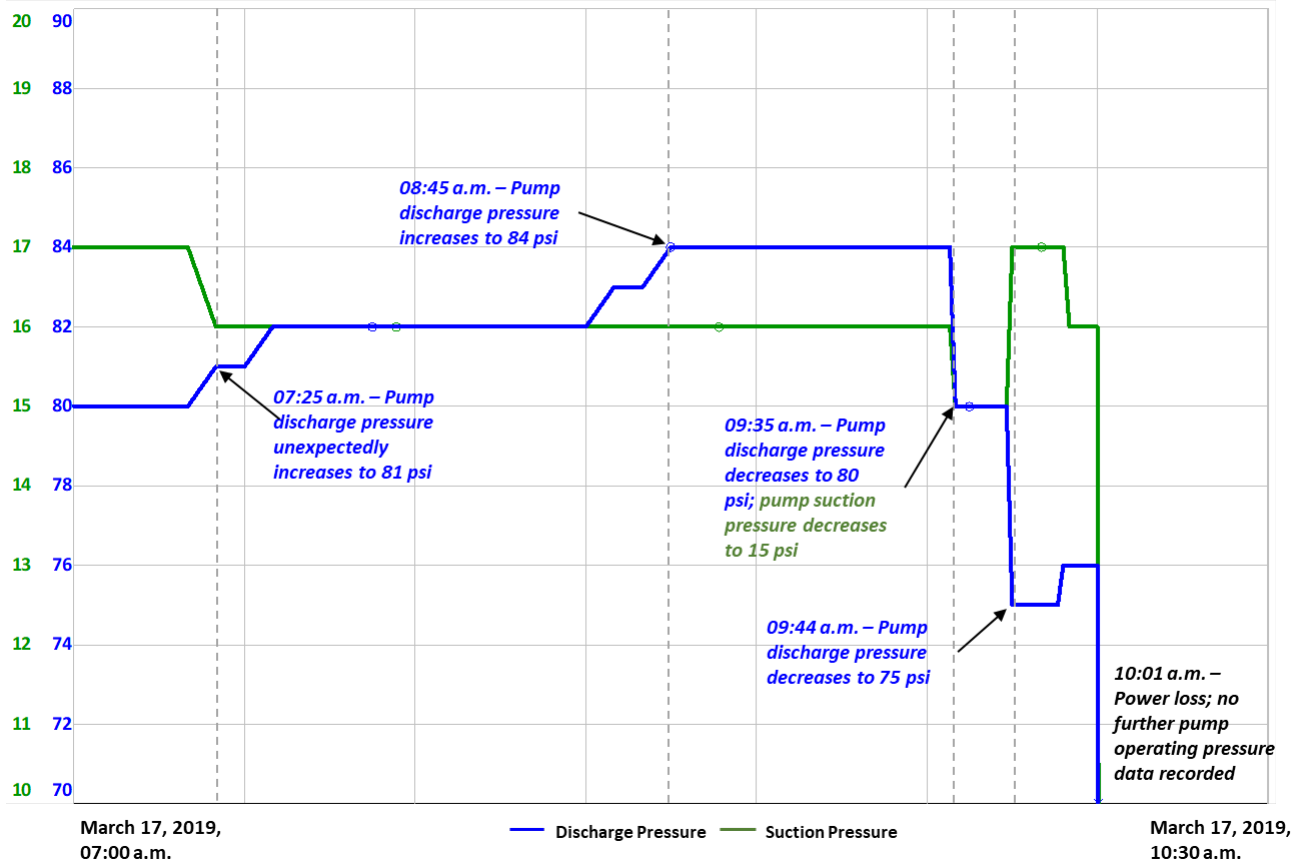
Tank 80-8 Pump Discharge Pressure & Suction Pressure

On the morning of March 17, 2019, as the Tank 80-8 circulation pump continued to operate, distributed control system (DCS) data for the tank indicated a series of unanticipated changes in the monitored operating pressures, flow rate, and tank volume. Beginning at approximately 7:25 a.m., the pump discharge pressure began to increase with no change in operation having occurred (**Figure 7**). By 8:45 a.m., the pump discharge pressure had gradually increased from 80 psi to 84 psi. At approximately 9:30 a.m., when the mechanical seal on the pump failed and butane-enriched naphtha product began to release to the atmosphere, the recorded tank level began to decrease, and recorded average flow rate^a for the tank, automatically calculated from changes in tank level measurements, began to increase (**Figure 8**). At approximately 9:35 a.m., the pump discharge pressure abruptly dropped to 80 psi, and within the next 10 minutes dropped further to 75 psi. At the same time, the recorded average flow rate of material from the tank had increased to about 158 barrels per hour (bph), and by 9:44 a.m. had increased to over 388 bph.

Figure 7. Recorded data historian trends showing recorded pump operating pressure data for Tank 80-8. (Credit: CSB)

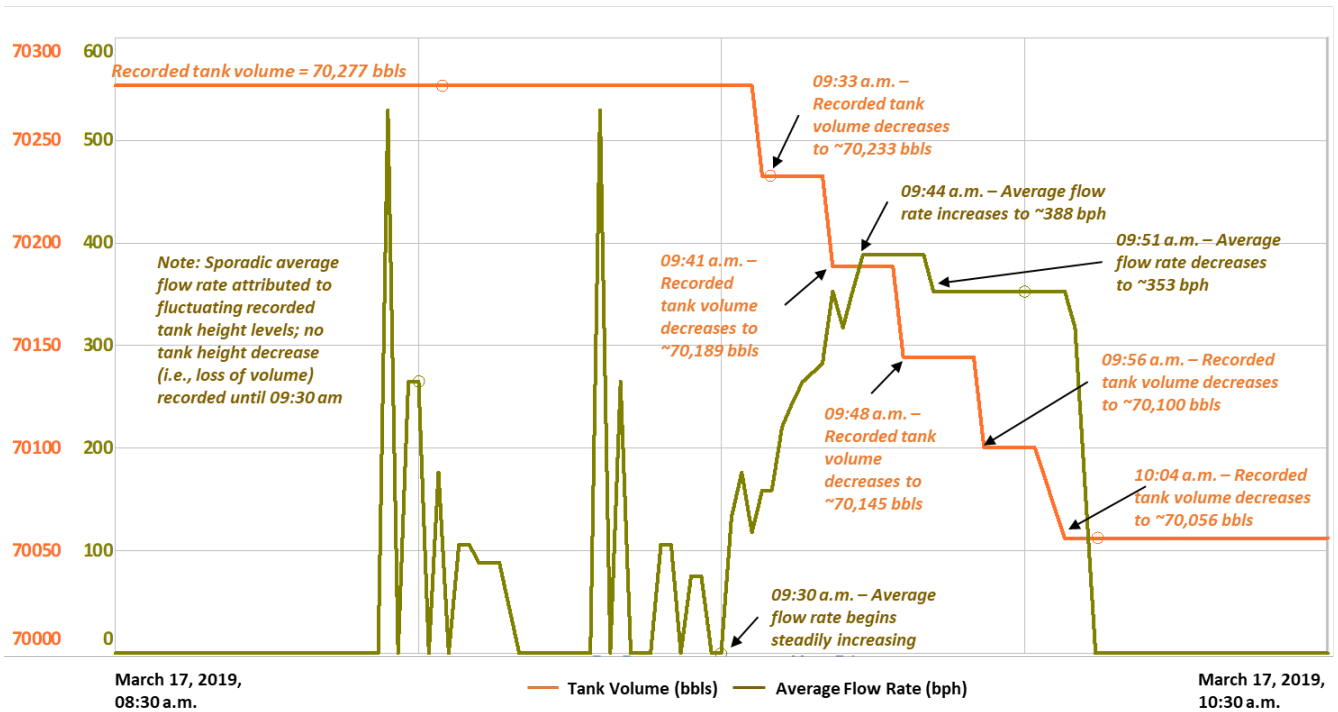
Tank 80-8 Recorded Tank Volume & Average Flow Rate

Figure 8. Recorded data historian trends showing recorded average flow rate and tank volume data for Tank 80-8. (Credit: CSB)

Between 9:30 and 10:00 a.m., the recorded tank volume^a in Tank 80-8 decreased by more than 177 barrels as the naphtha product continued to release from the failed pump.^b At 10:00:46 a.m., approximately 30 minutes after the release began, the butane-enriched naphtha product releasing from the Tank 80-8 piping manifold ignited (**Figure 9**). No operators were working outside in the First & Second 80's tank farm during this time frame. The acting shift manager was working in the adjacent Third 80's tank farm that morning and an operator was working in the nearby 100's tank farm. However, neither of them heard, saw, or smelled anything out of the ordinary during the time of the release. The First & Second 80's tank farm was not equipped with a gas detection system.

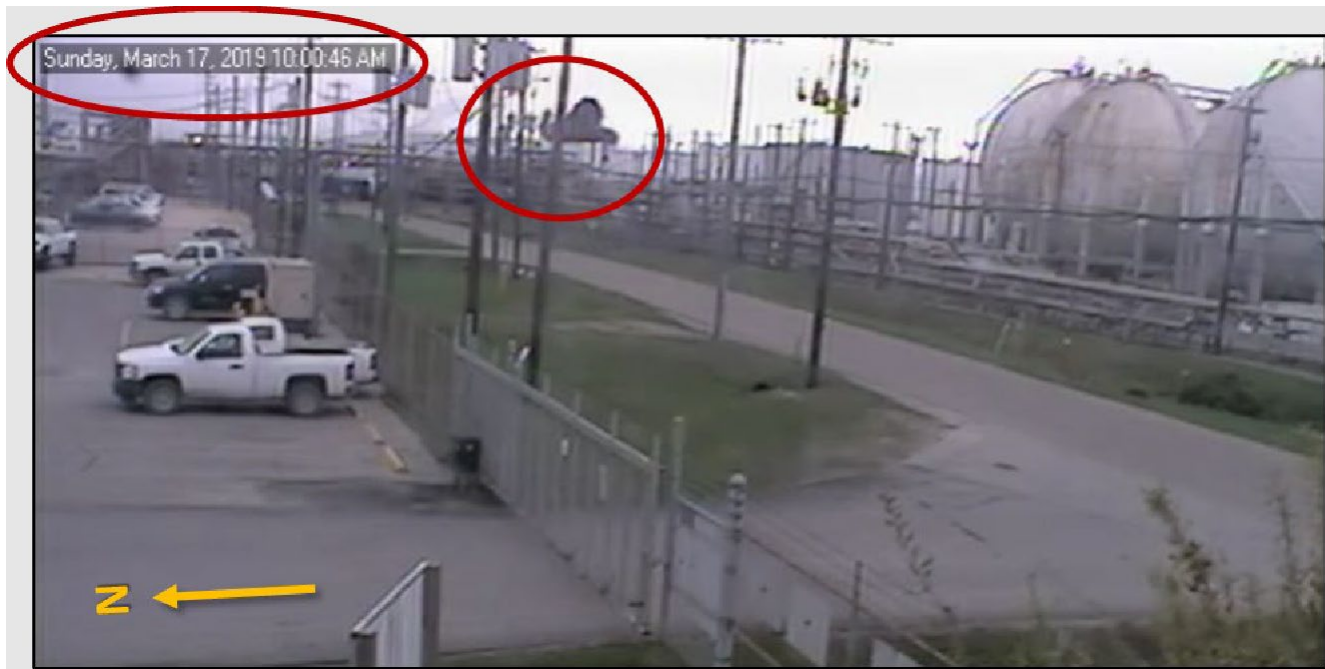
Figure 9. ITC Deer Park terminal security camera footage showing fireball over First & Second 80's Tank Farm at 10:00:46 a.m. on March 17, 2019. (Credit: ITC, annotations by CSB)

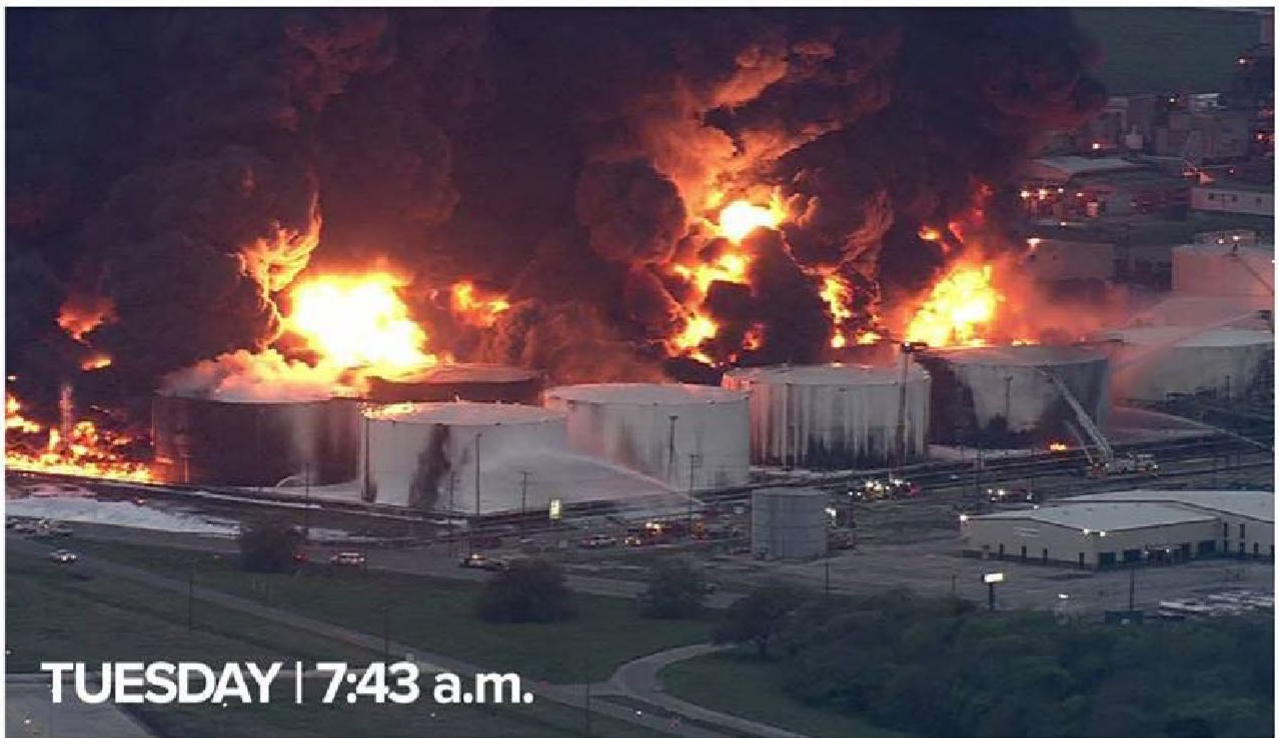
The fire at the ITC Deer Park terminal was extinguished by approximately 3:00 a.m. on Wednesday, March 20, 2019 (**Figure 14**).^h Later that evening, at approximately 5:20 p.m., a flare-up occurred at Tank 80-5 (**Figure 15**). Emergency responders were able to contain the fire quickly.

Figure 14. First & Second 80's tank farm on fire on Tuesday, March 19, 2019, and fully extinguished on Wednesday, March 20, 2019. (Credit: KHOU 11 News)

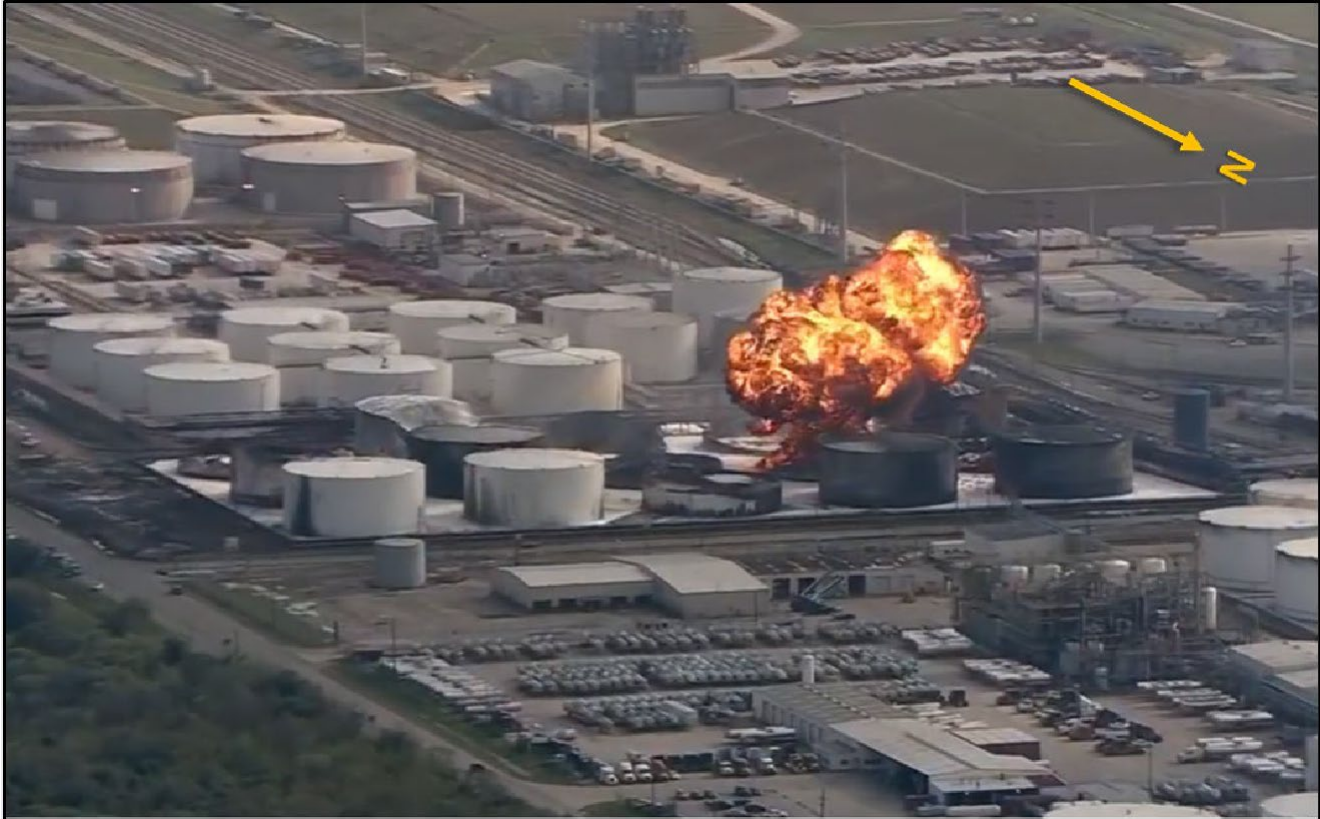
Figure 15. Tank 80-5 flare-up that occurred on March 20, 2019. (Credit: “Raw video ITC fire reignites in Deer Park”, annotations by CSB)

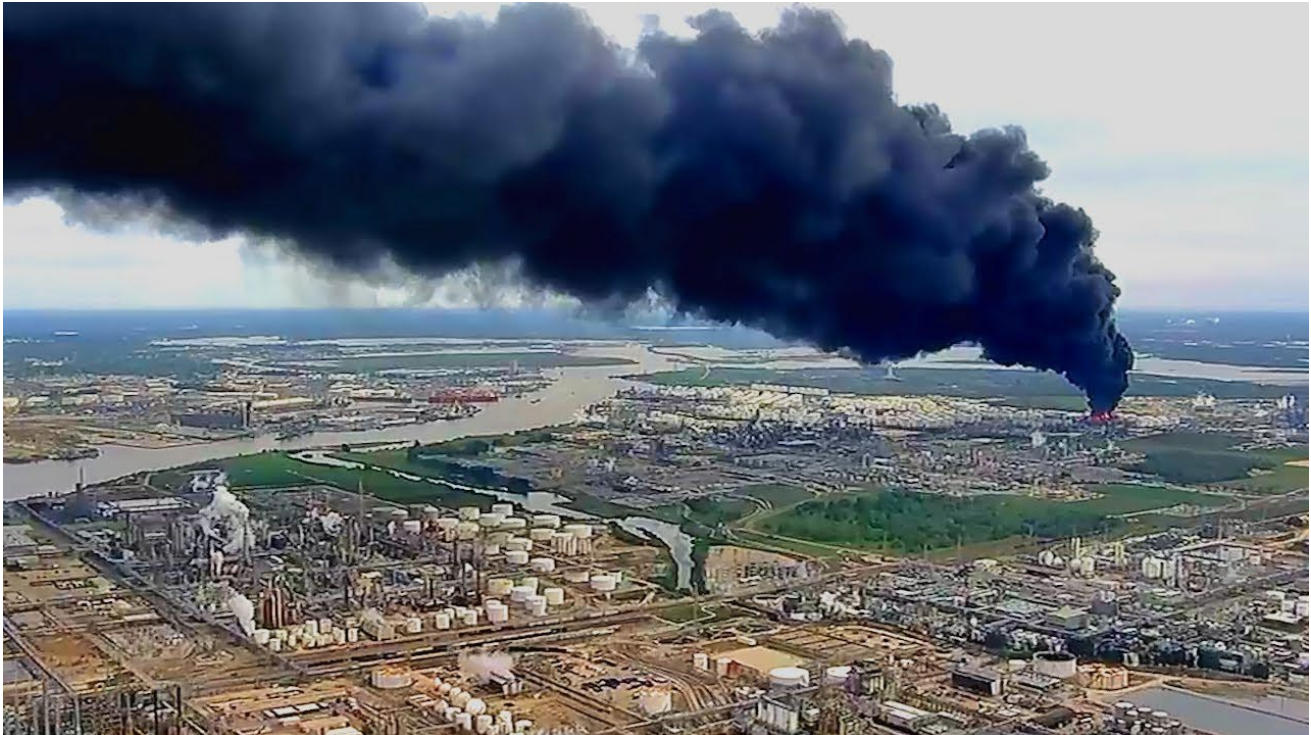
The ITC Deer Park incident had a direct impact on the surrounding community, including multiple shelter-in-place orders and closures due to benzene-related air quality concerns (**Figure 20**) [17]. Beginning on the morning of Sunday, March 17, 2019, the City of Deer Park issued a precautionary shelter-in-place order for a portion of the community and neighboring industrial facilities.^a That shelter-in-place order was later expanded to include the entire City of Deer Park, at which time a portion of State Highway 225 was also closed to all traffic. Working under a Unified Command with the EPA, TCEQ, Harris County, USCG, and other agencies, ITC was directed to conduct air monitoring.^b TCEQ, the EPA, and Harris County staff also deployed air monitoring resources beginning on March 17, 2019. The shelter-in-place order was lifted early the next morning after ITC publicly released an environmental report issued by CTEH that showed all air quality detections recorded were below levels that would represent a public health concern. The City of Deer Park also reopened State Highway 225.

Figure 20. Photo showing plume of black smoke from First & Second 80's tank farm fire. (Credit: The Texas Tribune [18])

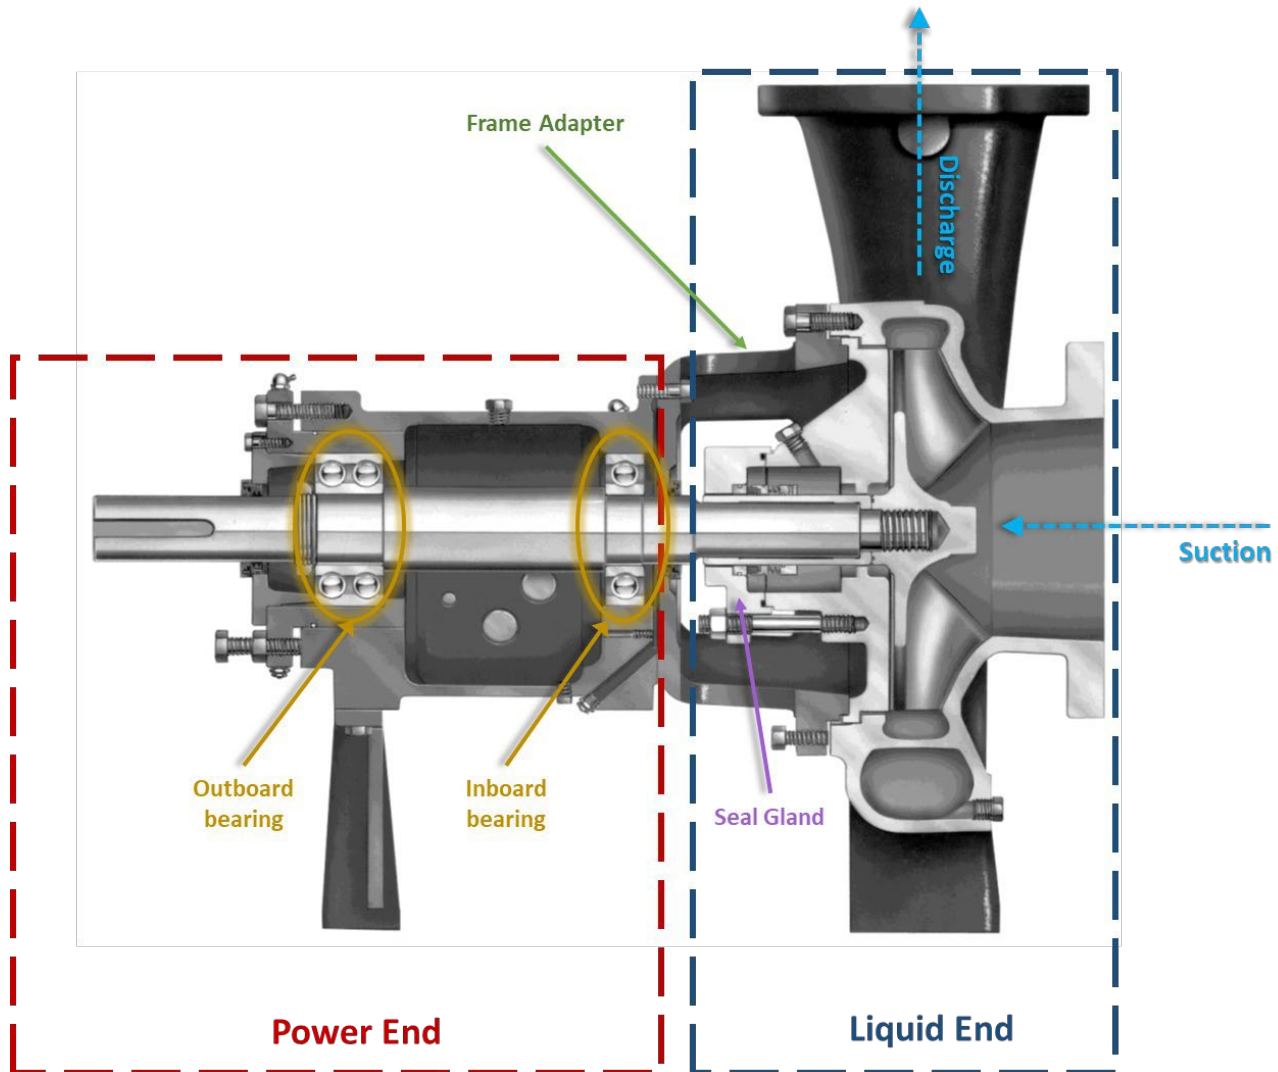
(**Figure 21**). The liquid end was comprised of the casing, impeller, seal chamber, and mechanical seal gland.^a The mechanical seal was designed to contain the butane-enriched naphtha product inside the seal chamber as it flowed through the pump. The seal gland mounted flush to the seal chamber cover and was secured by four gland nuts threaded onto the seal chamber studs that extended through designated slots on the seal gland. The power end was comprised of the bearing frame, pump shaft, two sets of ball bearings, and oil seals. The purpose of the two sets of ball bearings was to support the pump shaft. The inboard bearing was responsible for carrying radial loads,^b and the outboard bearing was responsible for carrying both radial and thrust (axial) loads. The pump shaft extended from the impeller through the seal chamber and bearing frame to the motor coupling.

Figure 21. Sectional view of *Goulds Model 3196 XLT-X* chemical process pump. This view identifies the pump's liquid end, power end, and rigid frame adapter. (Credit: *Goulds*, annotations by CSB)

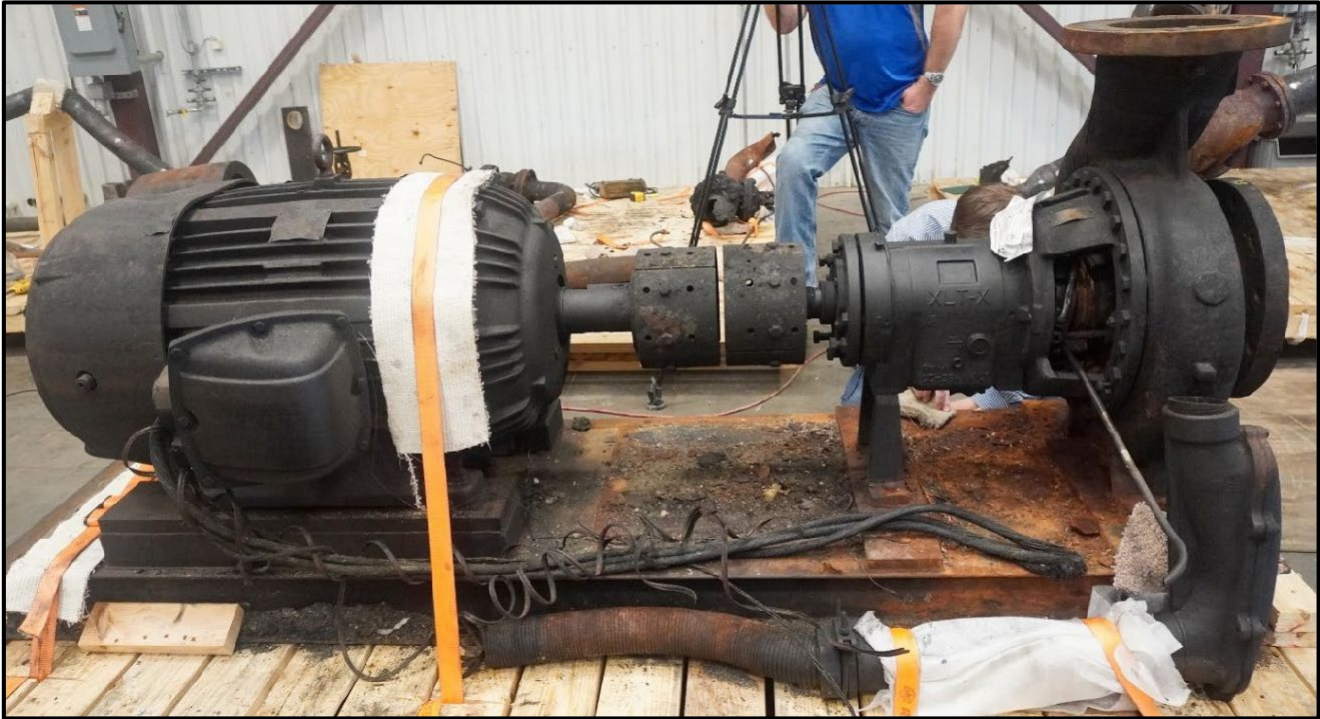
Following the incident, the Tank 80-8 circulation pump skid was transported to a third-party facility for inspection and teardown (**Figure 22**). The pump was fully disassembled to allow for visual examination of its individual components and documentation of their condition. Severe degradation and wear damage were observed on the pump shaft, seal, and outboard bearing. Substantial abrasive wear was visible on the pump shaft adjacent to the seal on the inboard side of the bearing housing (**Figure 23**). Extensive contact wear was also visible on the seal gland (**Figure 24**).

Figure 22. Tank 80-8 pump removed from ITC Deer Park terminal. Pictured is the pump kit on a pallet, as removed from the incident site. (Credit: CSB)

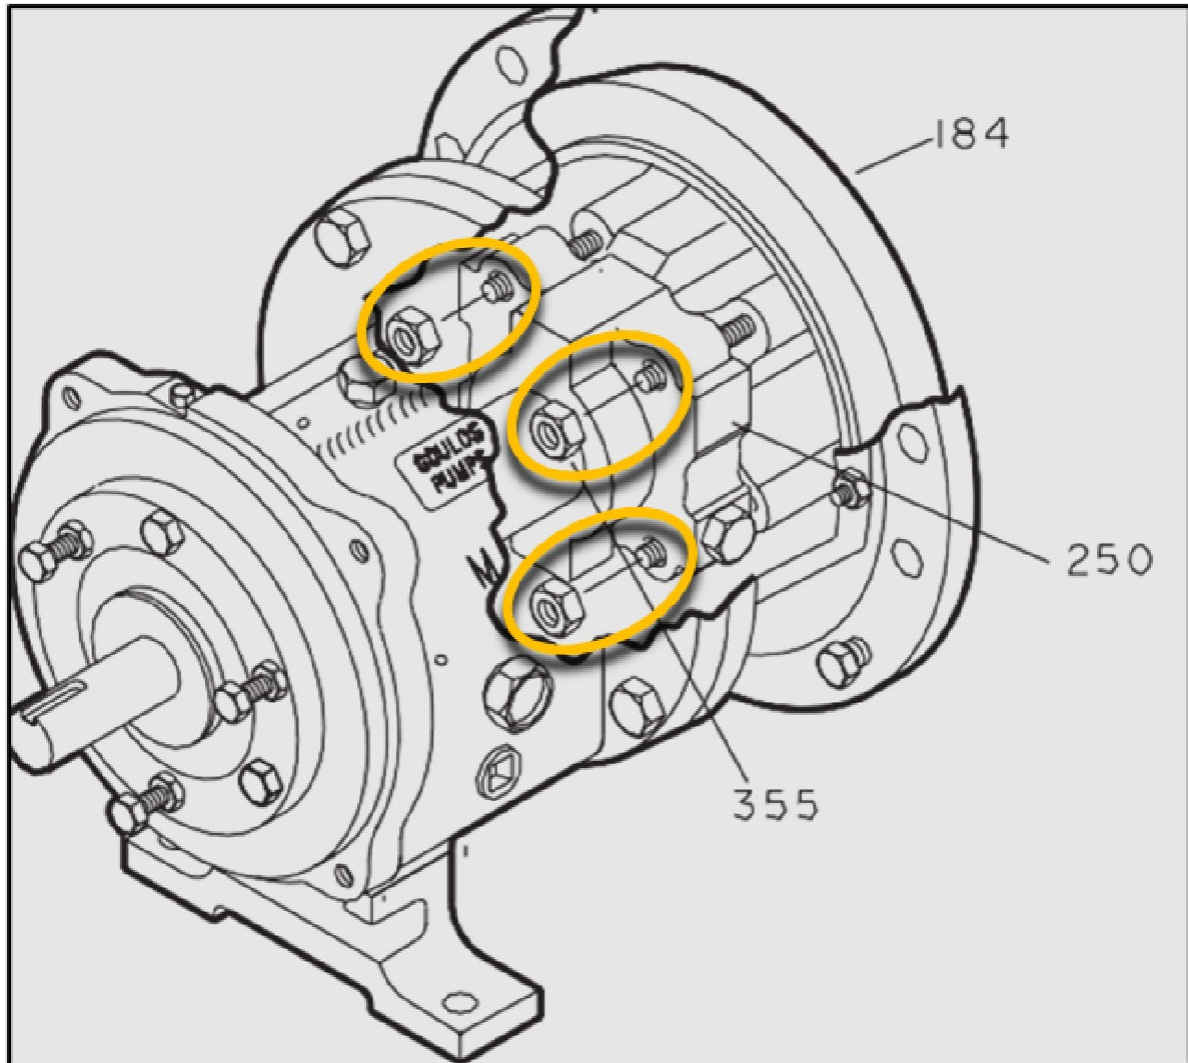
Four gland nuts secured the seal gland to the seal chamber cover to prevent the butane-enriched naphtha product from leaking from the pump, as shown in **Figure 25**. Post-incident inspection of the Tank 80-8 circulation pump revealed that none of the four gland nuts remained in place and that the seal gland was completely separated from the seal chamber cover (**Figure 26**). Additionally, the barrier fluid steel tubing used to provide lubrication

to the mechanical seal via the seal gland was found severed from the nearby external seal pot and wrapped around the pump shaft.

Figure 25. Cutaway drawing of *Goulds* chemical process pump showing the locations of three of the four gland nuts that held the seal gland in place against the seal chamber cover. *Note: fourth gland nut is not visible in drawing.* [Credit: *Goulds*, annotations by CSB]

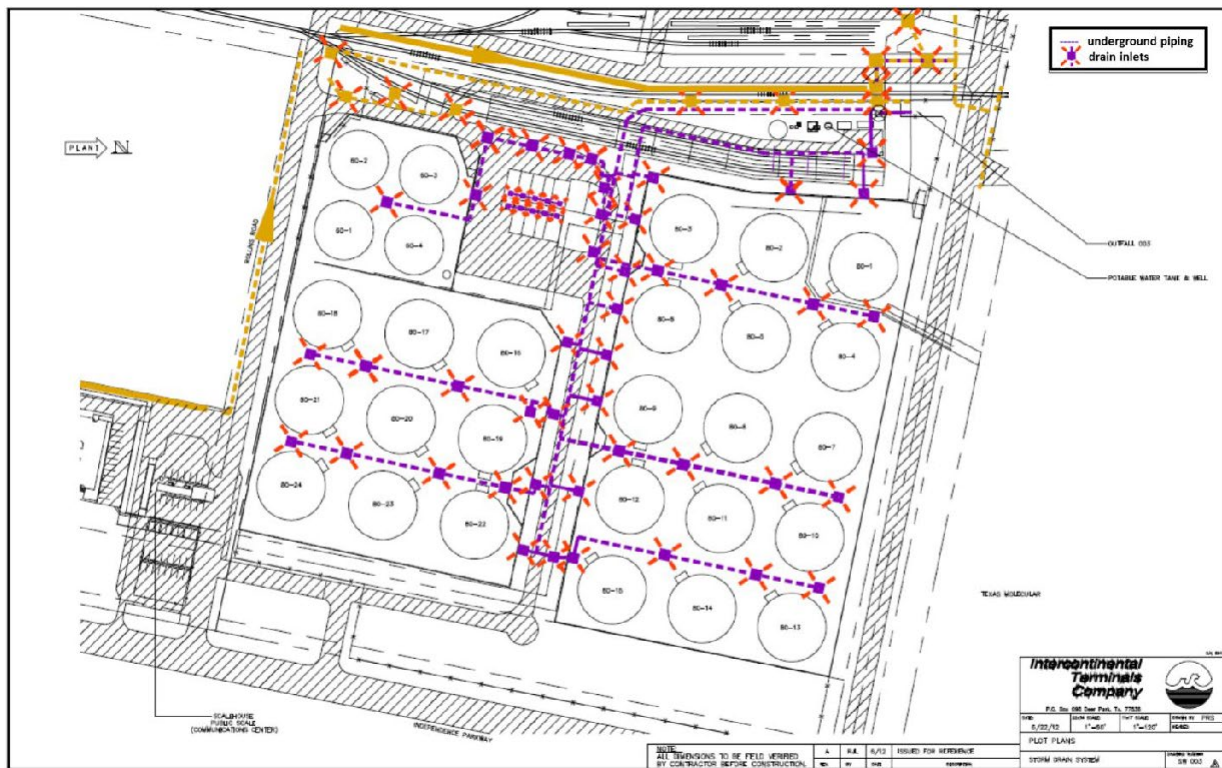
There were two drainage systems in place within the First & Second 80's tank farm: a chemical drain system and stormwater drain system. Materials collected in the chemical drain system were routed via underground piping to the terminal's wastewater treatment system. The stormwater drainage system was responsible for collecting stormwater from the First & Second 80's tank farm and directing it through pipes and control structures to an adjacent drainage ditch through a discharge location near the northwest corner of the tank farm (**Figure 31**). A Harris County drainage ditch was located just outside of the containment wall and inside of Tidal Road on the north side of the First & Second 80's tank farm.

Figure 31. Plot plan of First & Second 80's tank farm stormwater drain system. (Credit: ITC)

Although the First & Second 80's tank farm was designed largely in accordance with NFPA 30 (1973 edition), a convergence of several issues related to liquid accumulation resulted in complications during the emergency response, including:

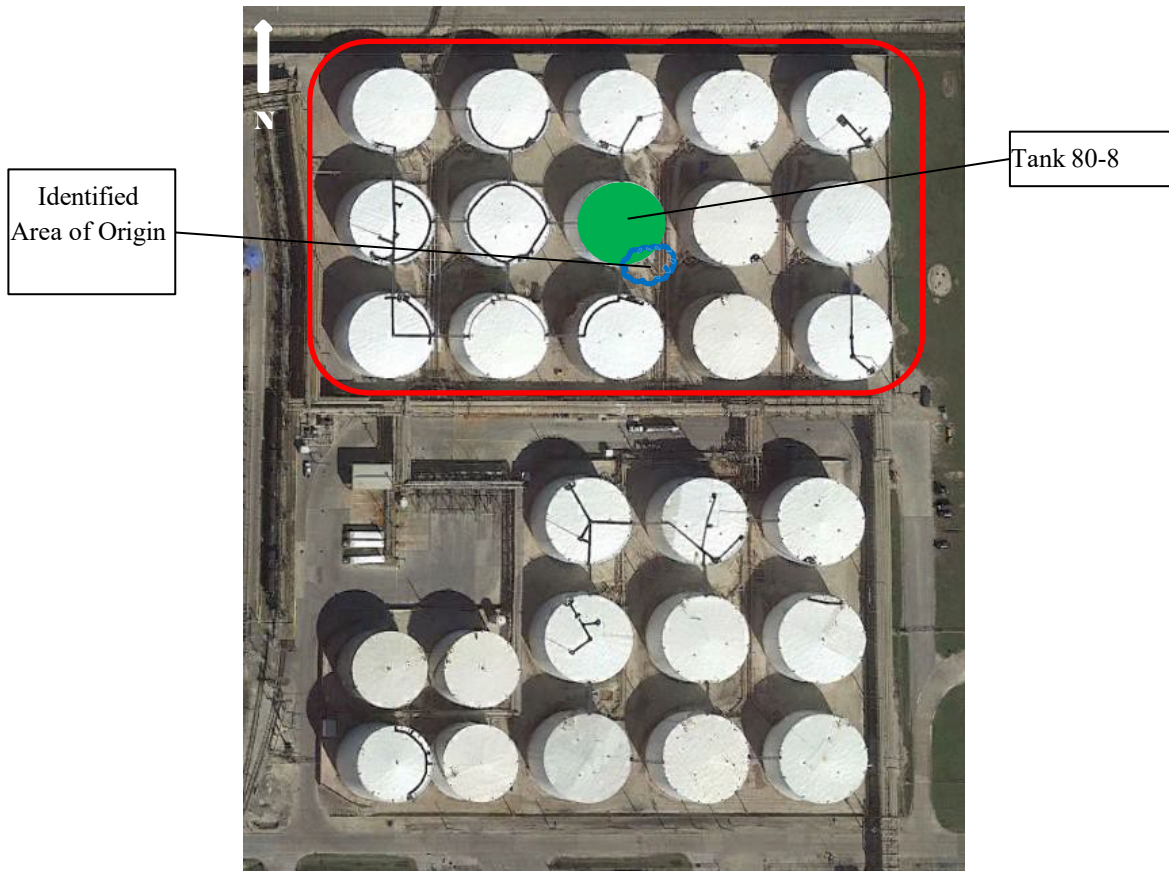
Figure 2: “First and Second 80’s Tank Farm” (Imagery Date: October 28, 2017) [Source: Google Earth Pro]
 (Tank farm encircled in red. Area of suspected origin identified via blue cloud. Tank 80-8 highlighted in green.)

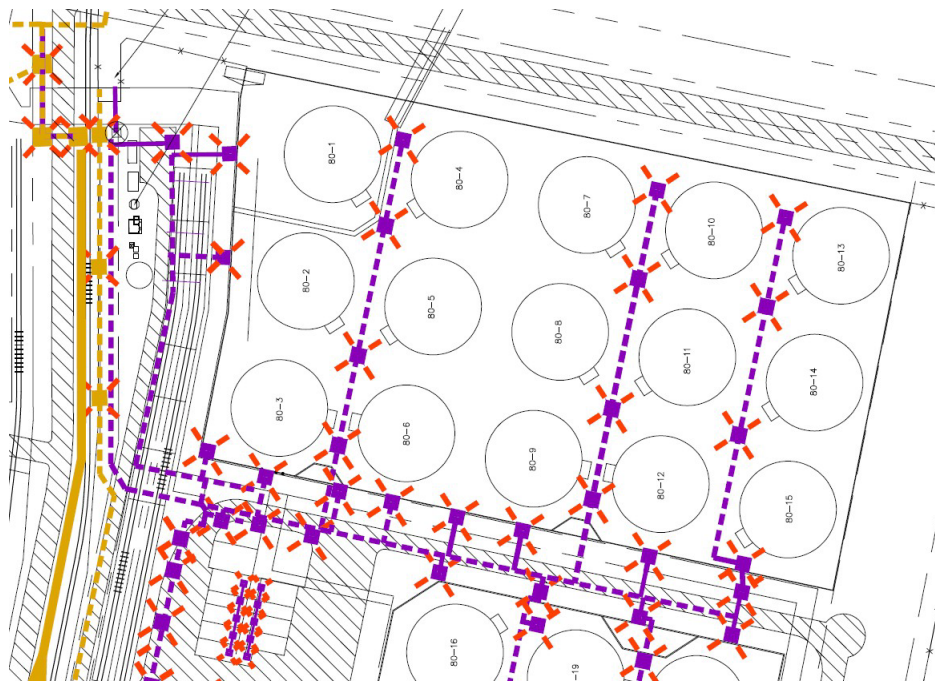
Figure 6: Drainage Arrangement

Drainage for chemicals within the tank farm is provided by a system of inlets placed between each of the fuel tank groups, with the piping between the outlets generally following the transverse piping described in the previous paragraph [ITC Drawings, various dates]. Three additional inlets are provided at the northwest area of the farm, with the piping running north-south to the west of the Tank 80-1 through 80-3 group. Each of the laterals are connected along the south of the farm, with east-west piping and eight inlets spaced across the area. The drainage connects to a similar system of piping for the tank farm to the south for the drainage piping transfers out of the area.

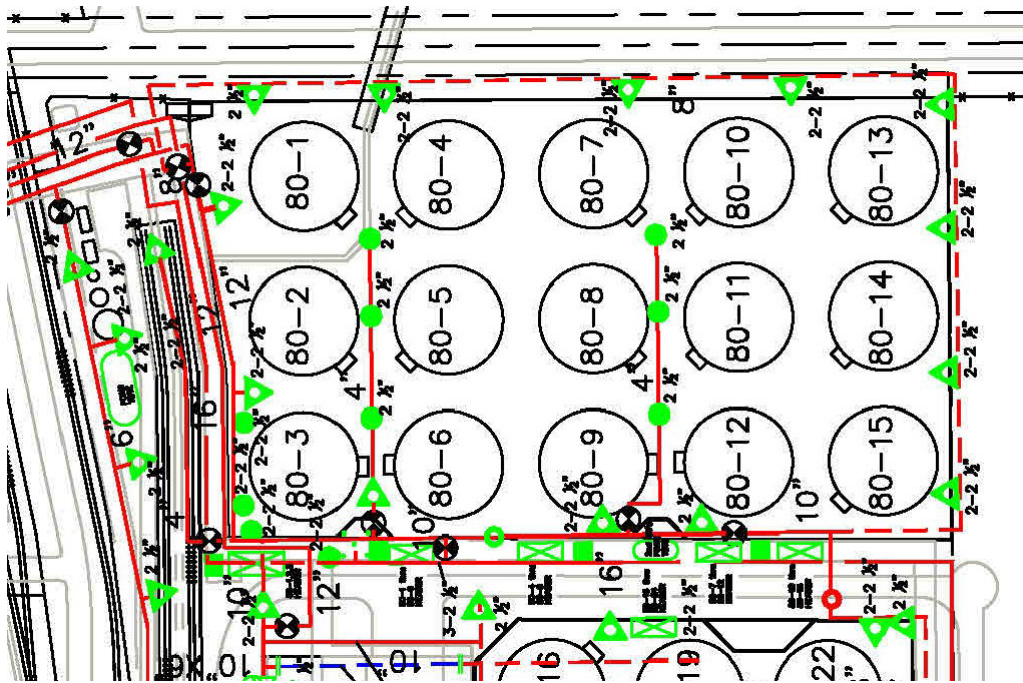
Figure 7: Fire Equipment Layout

With respect to fire protection systems, there are multiple layers present [ITC Drawings, various dates; CSB Interview with ITC Vice President of Safety, Health, Environmental, Security, Regulatory Compliance and Operations (VP of Safety), 2019b]. Each of the tanks is provided with an installed foam fire suppression system, which is manually supplied and operated. The supply connections for the systems are located along the south containment wall, outside the containment wall. Hydrants and monitors (see definitions), the majority being combination units, are located around the perimeter of the tank farm. Additional monitors are provided between the Tank 80-1 through 80-3 and Tank 80-4 through 80-6 groups, with three monitors installed to spray water on surfaces that are otherwise difficult to access. A similar line is provided in the segment between the Tank 80-7 through 80-9 and Tank 80-10 through 80-12 groups. Water-spray systems were also installed on the tank farm manifold systems. These water-spray systems could also flow foam and required manual activation. The activation points for these systems is also on the exterior of the south containment wall. See Figure 7.

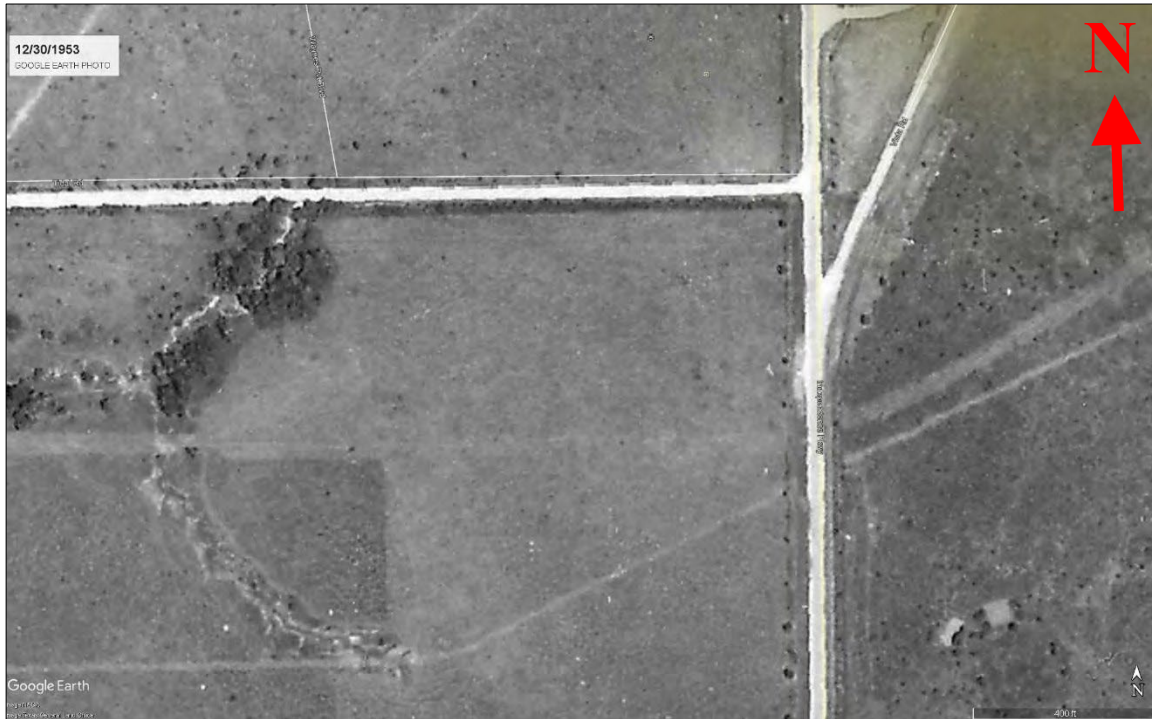
The roads currently named as Tidal Road and Independence Parkway existed at the site prior to the construction of the tank farm in a general location that is consistent with the existing roads.⁵ There did not appear to be a concrete lining to the drainage ditch on the south side of Tidal Road in this aerial photo (photo 1). The tank farm was not constructed at this point in time.

Photo 1: Site of tank farm prior to construction, aerial imagery date: 1953, source: Google Earth Pro

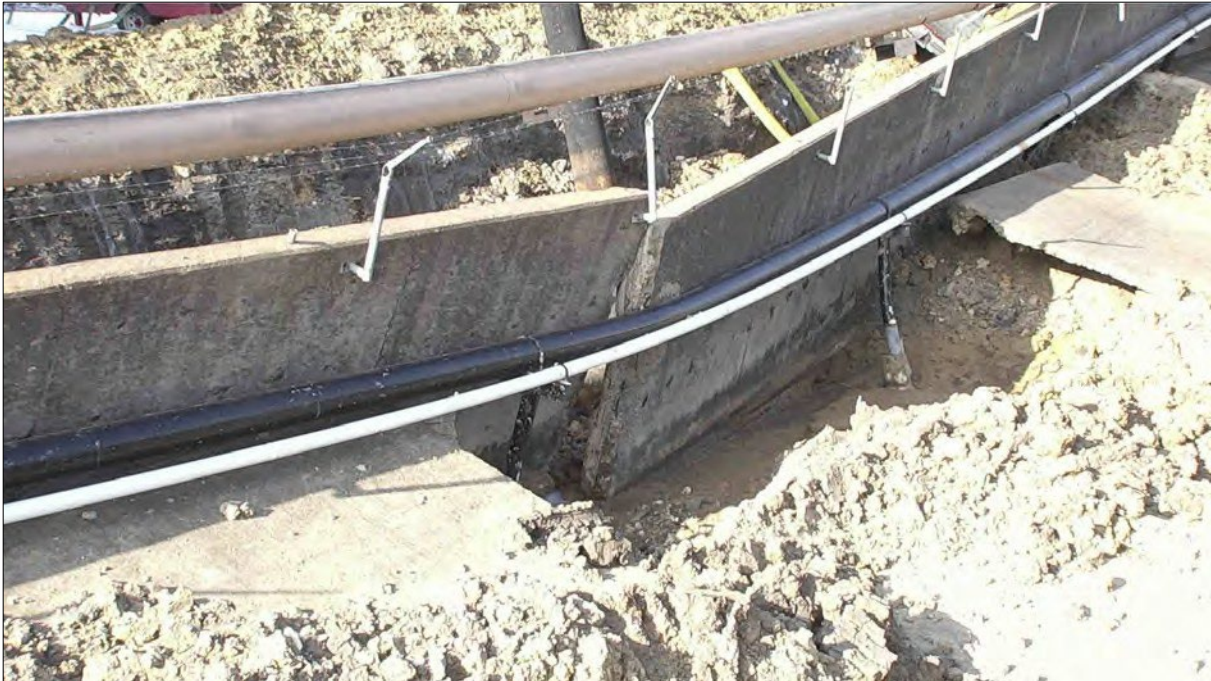
Photo 9: Close-up photo of containment wall breach provided by CSB¹⁷

A close-up photo of the primary breach location can be seen in Photo 9. The soil had been eroded away from both sides of the containment wall at the breach. The wall had separated at a construction joint, and no dowels were visible spanning across the construction joint. The bottom of the wall was not visible in this photo, and it cannot be determined from this photo if the wall had a footing. The soil on the lower- right corner of the photo was soil placed after the breach to form the temporary dike wall. The temporary dike wall constructed by the responders inside the containment area can be seen in the upper left corner of the photo.

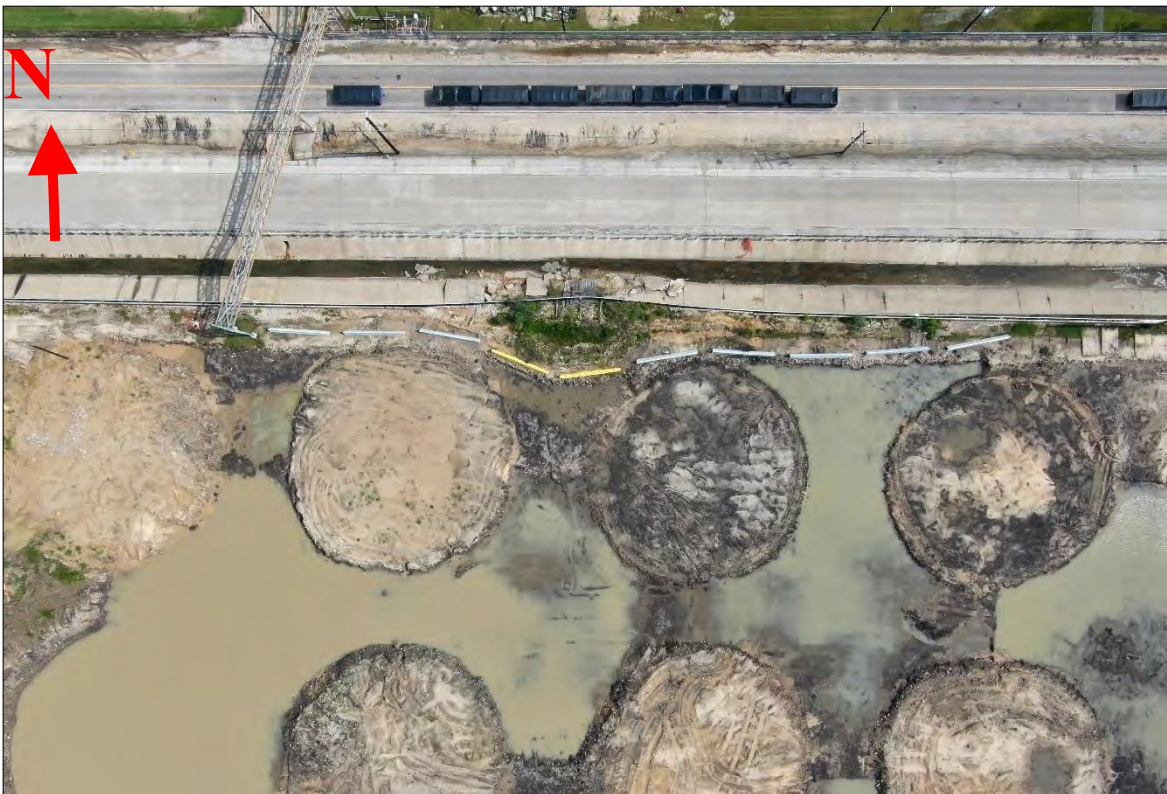
At the time of our site visit, remediation measures had been performed. These included draining the product and water from the site as well as removal of the existing tanks and above-grade piping. The top surface of the soil inside the containment area appeared to have been significantly disturbed by these initial remediation measures. The additional soil brought in to construct the containment remained in place. New T-rail Jersey barriers were in place, likely to prevent equipment involved in the remediation of the tank farm from entering the section of the breach. The elevated pipes that were located just outside the tank farm wall had additional temporary supports added where the original supports were disturbed in the breach. Erosion ditches at the area of the breach had been backfilled. Some sections of the damaged concrete slab that had lined the drainage ditch between the tank farm containment wall and Tidal Road had been removed, as well as sections of the damaged portion of the containment wall. The immediate area of the breach was thoroughly disturbed from the remediation and stabilization operations. However, sections adjacent to the breach along the containment wall appeared to remain minimally disturbed since the incident (Photo 10).

Photo 10: Aerial view of site during July 7, 2021 site visit

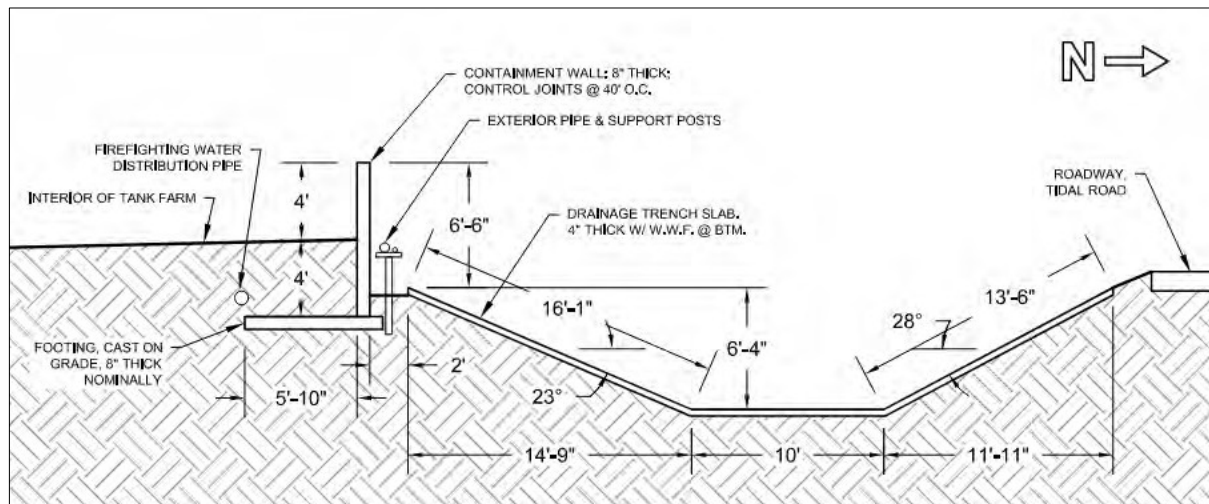
Figure 3: Cross section sketch of the containment wall

Measurements of the existing wall and drainage ditch were taken to construct a cross section sketch of the area (Figure 3). Measurements of reinforcement in the containment wall were made at locations where the containment wall had been broken by equipment during remediation efforts (Photo 11).

The containment wall was a cast-in-place concrete wall 8-inches thick and extending above the interior grade of the tank farm approximately 4 feet. The depth of the containment wall into the soil was not able to be determined at this visit. The wall had impressions from a panelized formwork system and through-wall break-off form ties, or snap-ties, spaced regularly in the horizontal and vertical direction, indicating it was constructed free-standing with a panelized formwork system on each face (photo 12). The wall was reinforced with two layers of deformed mild-steel reinforcing bars. The wall was cast in sections, with a construction joint every 40 feet. The joints were formed with a shear-key at the joint and a ribbed-wing centerbulb PVC waterstop incorporated into the construction joints to prevent liquids from leaking through the wall at the joints (photo 13 & 14).

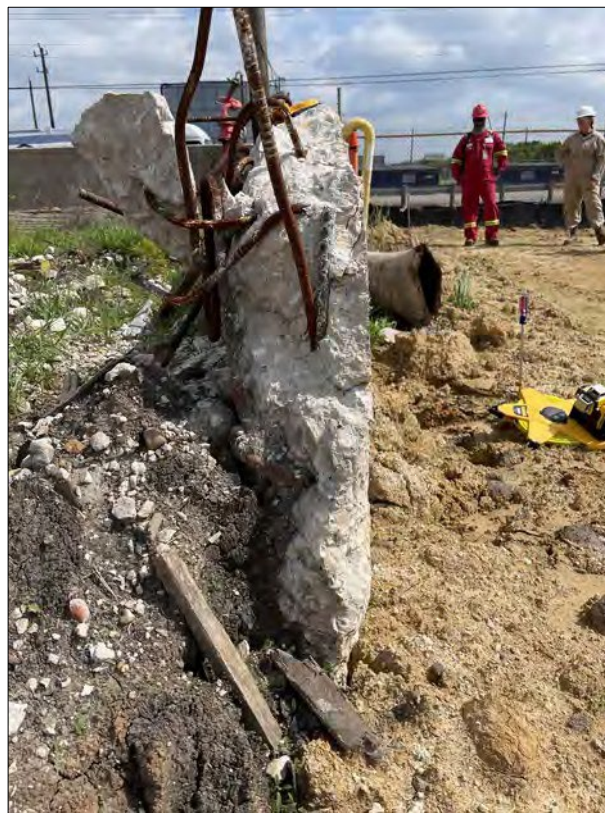
Photo 11: Exposed reinforcement at a section of the east containment wall where the wall was removed during remediation efforts

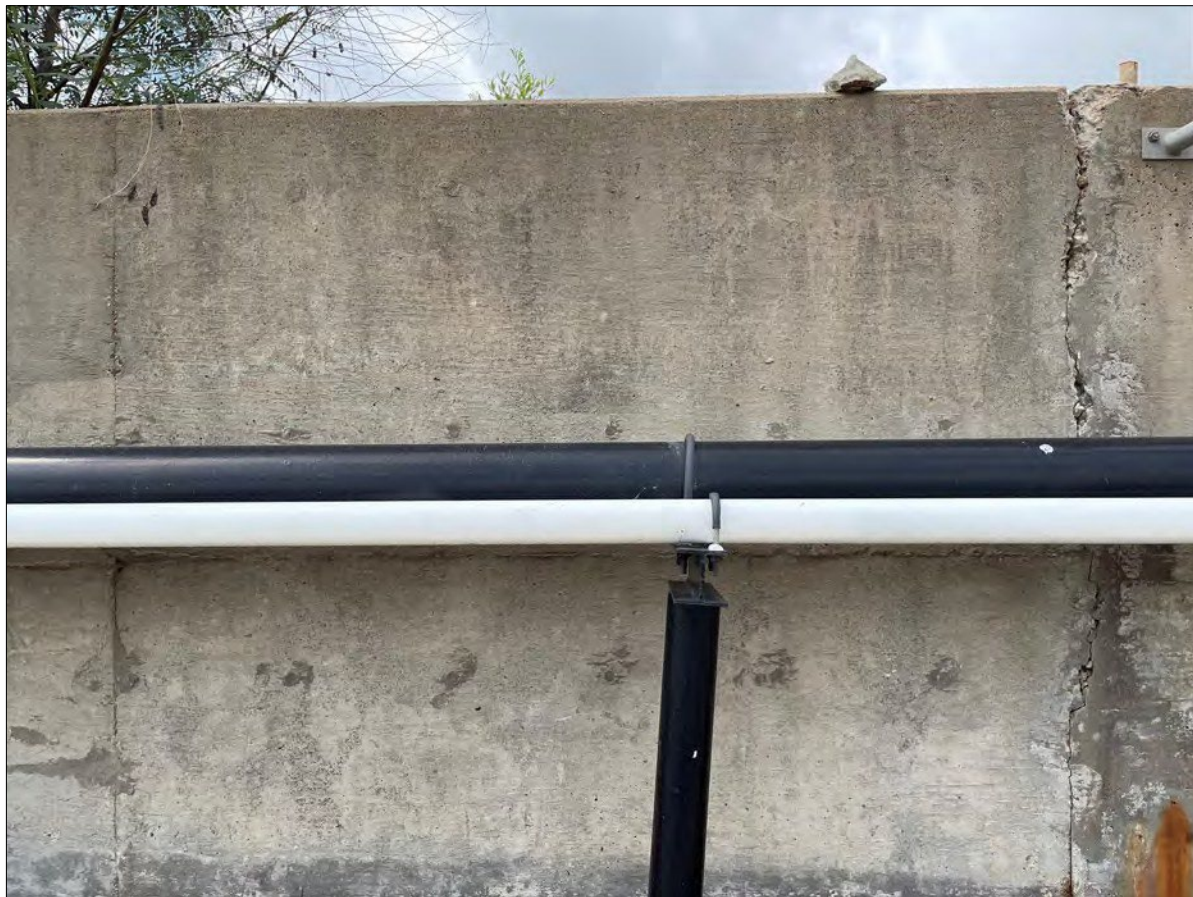
Photo 12: North concrete retaining wall, outside face. Form tie marks on wall
