Accident- Tank Farm explosion and fire in Deer Park, Texas

15 PDH

**Professional Development Hours (PDH) or
Continuing Education Hours (CE)
Online PDH or CE course**

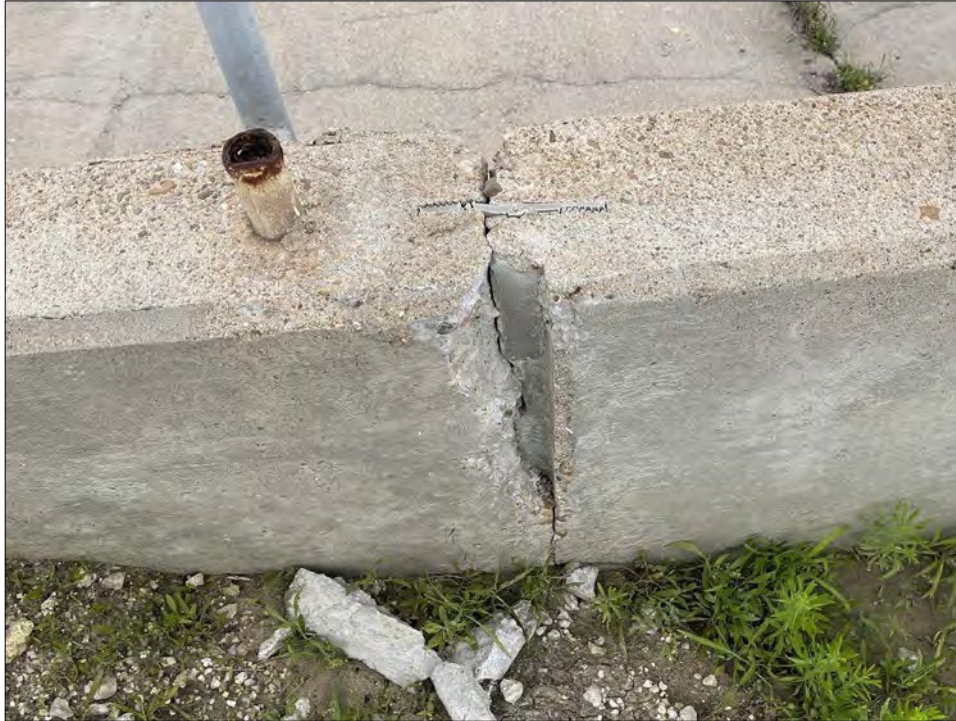
The containment wall was a cast-in-place concrete wall 8-inches thick and extending above the interior grade of the tank farm approximately 4 feet. The depth of the containment wall into the soil was not able to be determined at this visit. The wall had impressions from a panelized formwork system and through-wall break-off form ties, or snap-ties, spaced regularly in the horizontal and vertical direction, indicating it was constructed free-standing with a panelized formwork system on each face (photo 12). The wall was reinforced with two layers of deformed mild-steel reinforcing bars. The wall was cast in sections, with a construction joint every 40 feet. The joints were formed with a shear-key at the joint and a ribbed-wing centerbulb PVC waterstop incorporated into the construction joints to prevent liquids from leaking through the wall at the joints (photo 13 & 14).

Photo 13: Construction joint with cast-in concrete shear key and centerbulb waterstop

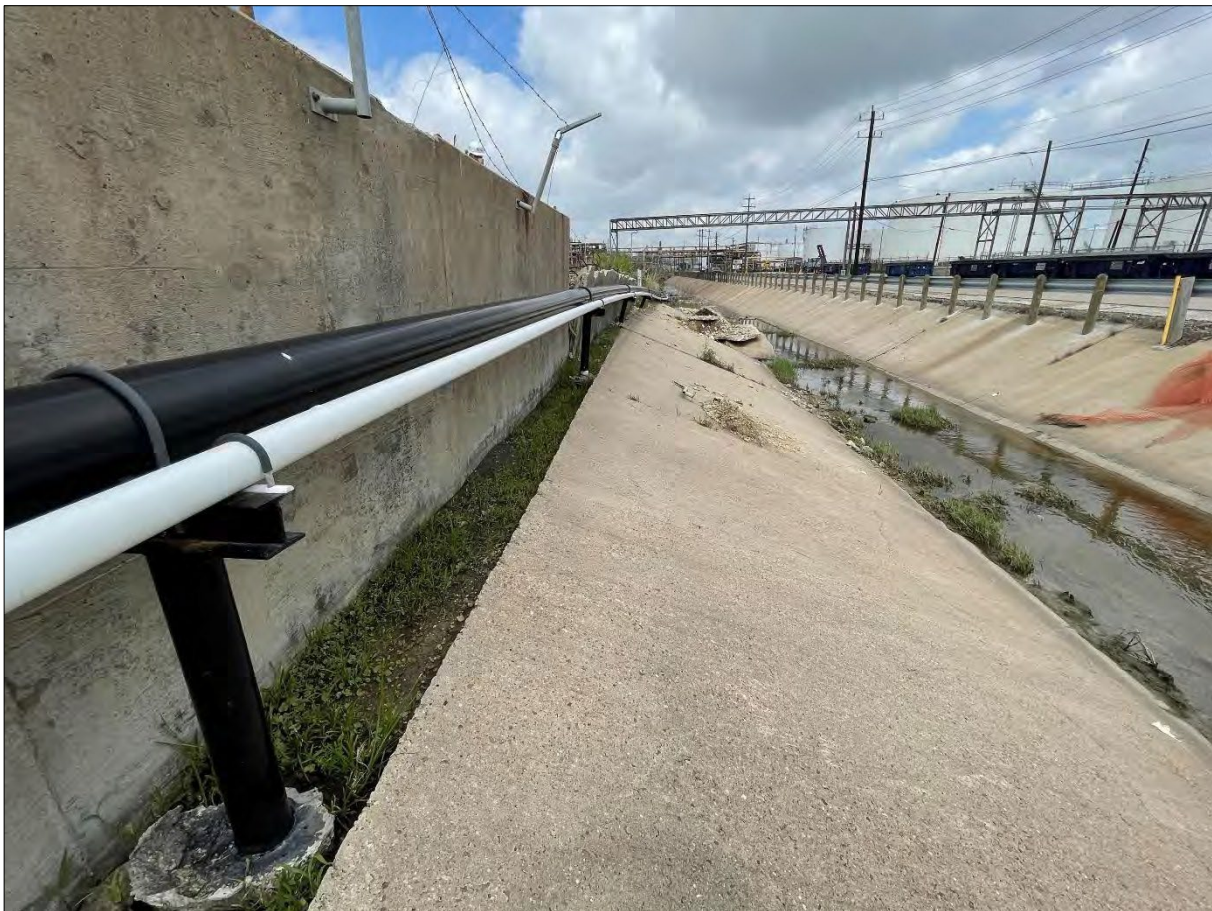
The drainage ditch between the containment wall and Tidal Road was a concrete-lined structure with a flat bottom and sloped side walls (photos 15 & 16). The concrete slab was approximately 4-inches thick, with welded-wire-reinforcement observed at broken sections of the concrete, typically located near the bottom of the slab. The concrete slabs were cast in sections, with construction joints between the slabs (photo 17). The welded-wire reinforcement did not span across the construction joints. Holes through the slab were observed along the bottom edge of the sloped side-wall slabs, appearing to have the purpose of providing drainage of groundwater from behind the side slab into the drainage ditch. In the areas adjacent to the breach that appeared un-disturbed, sections of the sloped sidewall concrete slab had buckled upward in the middle of the slab.

Photo 15: Drainage Ditch, undamaged section at north-east corner, looking west

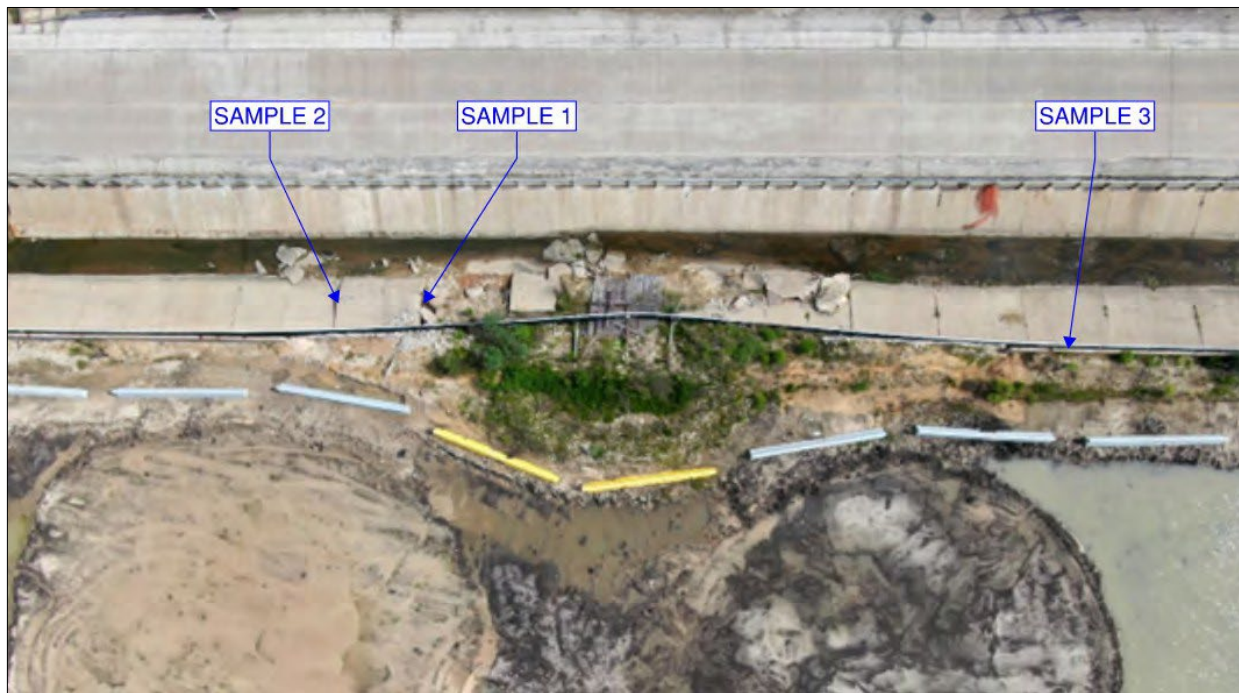
Photo 18: Soil Sample Locations relative to breach in containment wall

During this visit, three isolated soil samples were taken with a hand trowel at a shallow depth from areas assumed to be soils existing at the time of the breach with locations shown in photo 18. Sample 1 was taken on the north side of the containment wall just west of the breach, at a location beneath a buckled slab of the drainage ditch (photo 19). Sample 2 was taken on the north side of the containment wall, further west of the breach, at a location beneath a buckled slab of the drainage ditch (photo 20). Sample 3 was taken on the north side of the containment wall, east of the breach, in an area that was not disturbed by the shifting wall of the breach (photo 21). No samples were taken inside the containment area since it appeared that the soil surface had been significantly disturbed during remediation efforts at the site and would therefore not be representative.

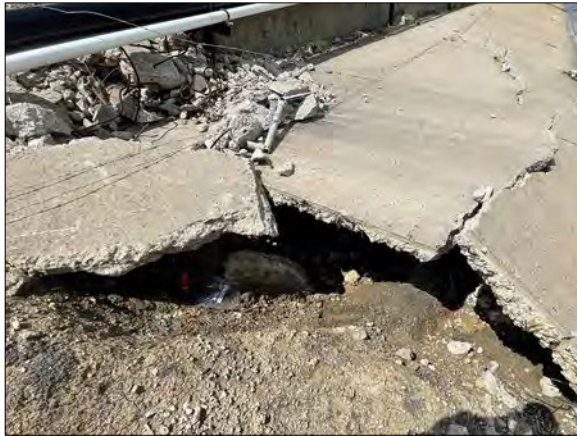
Photo 19: Location of Sample 1

Sample 1 appears to be a stiff mottled tan and gray silty deltaic clay. Its classification would be most likely “CH” when classified in accordance with the Unified Classification system. Sample 2 appears to be a dark gray deltaic clay, also likely to be classified as a CH. Sample 3 appears to be a moist soft gray marine clay CH. Both Samples 1 and 2 appear to have been disturbed and are poorly consolidated, whereas Sample 3 is fine grained and well consolidated. Samples 1 and 2 are assumed to be typical of the soils located underneath the sloped side slab of the drainage ditch. Sample 3 is assumed to be similar to the soils inside the containment area at the containment wall. The soil in Samples 1 and 2 appears to be moderately sensitive. Soil sensitivity is a characteristic describing the loss of soil strength when changing from an undisturbed natural condition to a disturbed condition through excavation and re-compaction. Soils with higher sensitivity lose a greater proportion of their strength when disturbed. Sample 3 appears to have a high shrink-swell potential, or a potential to change volume as water content in the soil changes. Soil swelling can increase the pressure on retaining walls considerably higher than normal pressures.

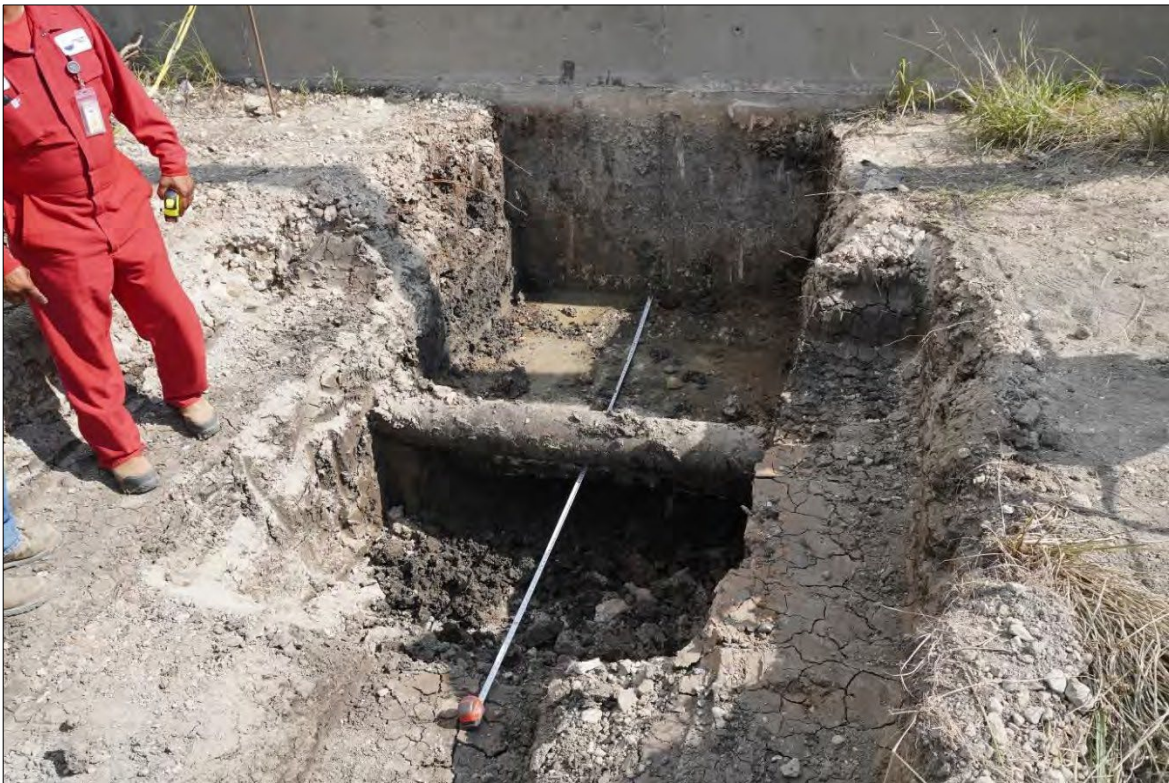
ITC excavated a section of the interior face of the containment wall on June 9, 2022. Atlas Engineering was unable to visit the site during the excavation, however CSB personnel were able to observe the condition of the wall after the excavation and take measurements (Photos 22 & 23). Measurements taken in the excavation area were used to refine the cross-section sketch through the containment wall shown above in Figure 3. The excavation revealed the containment wall extends down 4 feet below the grade level of the interior of the tank farm. There was a horizontal slab extending approximately 5 feet south from the interior face of the containment wall. This slab had a highly irregular edge and bottom surface, indicating it was cast against grade. No standing water was seen in the footing, indicating the natural groundwater level was below the base of the footing. The excavation also revealed the location of an underground firefighting water distribution pipe that supplied the fixed firefighting monitors located along the north wall inside the tank farm.

Photo 22: Containment wall footing excavation, south face of north wall, inside containment area

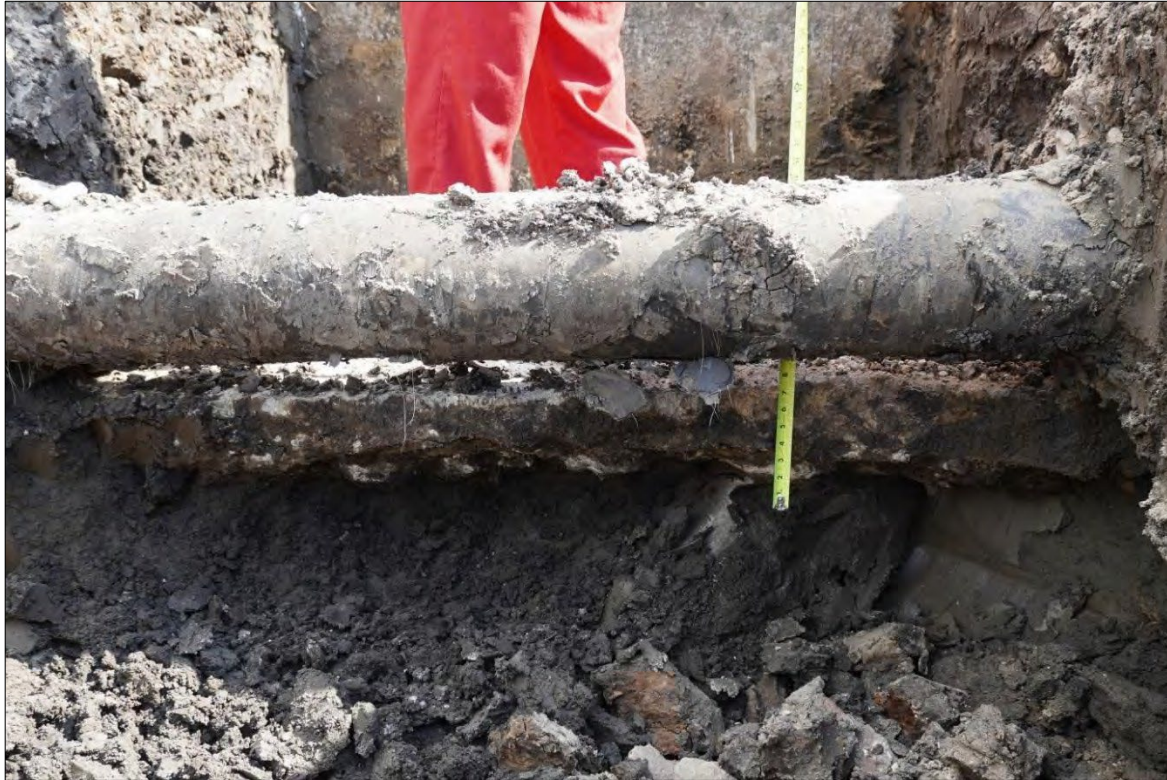
Photo 23: Containment wall footing and underside of footing

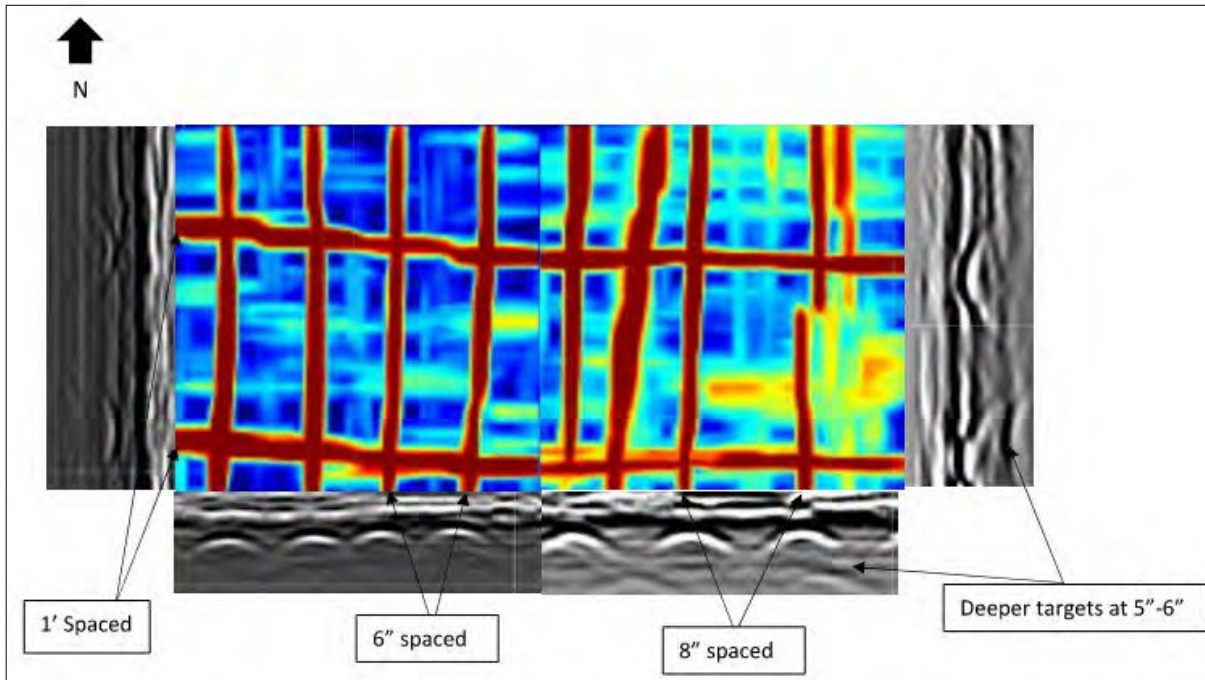
A contractor was utilized to perform a ground penetrating radar (GPR) scan of the foundation in an attempt to determine if reinforcement was present in the foundation and its general configuration. Due to the irregular surface of both the top and bottom of the concrete footing, the GPR instrument was limited in the information it could provide. The depth of the concrete could not be definitively identified due to the irregularities of the bottom surface of the concrete, a result of being cast against grade. GPR did indicate the presence of reinforcement in the concrete foundation, running both longitudinally and across the slab.¹⁸ GPR was not able to identify if any dowels existed between the horizontal concrete slab serving as the footing and the vertical concrete wall forming the containment wall. Longitudinal reinforcement was detected approximately 12-inches on center, while transverse reinforcement was detected with spacings varying from 6 to 8-inches on center (Figure 4). The size of the reinforcement could not be determined from the GPR results. Excavation on the exterior side of the containment wall was not possible due to the presence of active pipelines in the area.

Figure 4: GPR scan results of retaining wall foundation slab from Holes Technology LP Report
